## 2023 Battery Ratings Chart and Battery Maintenance FAQs Update

## TECH LINK

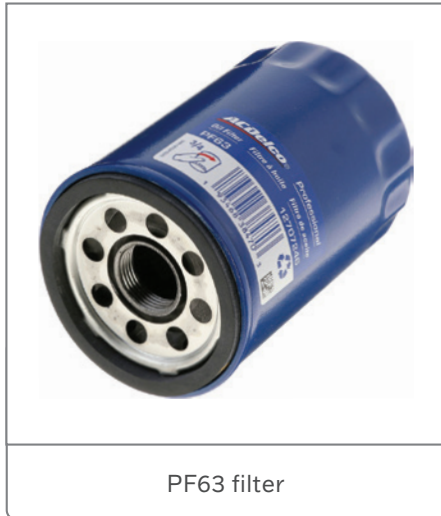
The PF63 engine oil filter will be the factory-installed filter for applicable 2023 models equipped with the 6.6L Duramax diesel engine (RPO L5P). The current PF26 engine oil filter also is compatible with these diesel engines.

The PF63 filter is 3/4 inches (19 mm) narrower than the PF26 filter, but it has a taller pleat height, which maximizes volume efficiency and cold flow performance.

Service Information and the Parts Catalog will be updated shortly. For more information and part numbers, refer to #PIP5870.

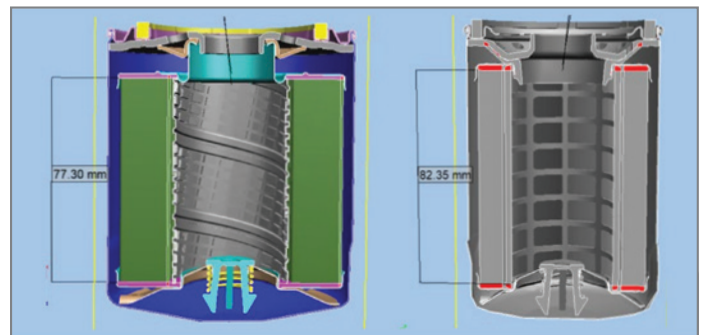
PF63 filter (right) is narrower, yet has a taller pleat height than the PF26 filter (left).

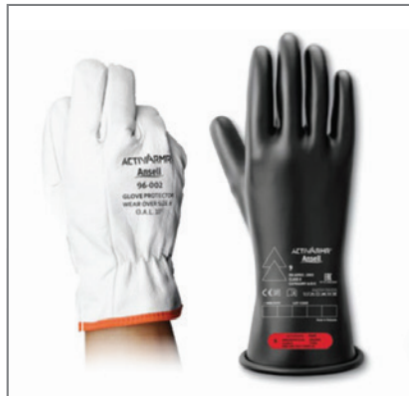
Leather protector glove and  
rubber insulation glove

The leather protector gloves by themselves do not offer any protection against high or low voltage. Always wear the outer leather protector gloves over the inner rubber insulator gloves.

The rubber insulating gloves include a stamped date that indicates when the gloves were “originally or last tested electrically.” Rubber insulating gloves must be retested electrically by a certified lab 6 months after first use. The lab will restamp the gloves with the new “tested” date.

If glove damage is observed, do not use the gloves and have them tested and recertified or replace them.

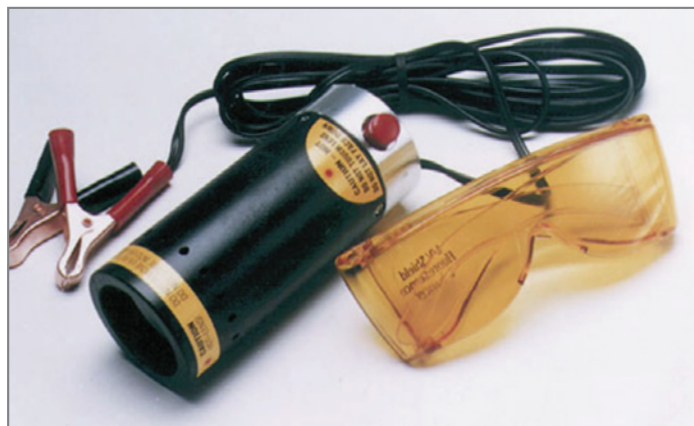
The leak may appear to be related to the lower-crankcase extension to block-sealing surfaces or to block porosity. However, warranty analysis shows that this oil leak may be coming from the turbocharger oil feed pipe fitting at the engine block or from the engine oil cooler gasket.

Check the engine oil cooler gasket and the turbocharger oil feed pipe fitting in the block just below the engine oil cooler. If the engine oil cooler is removed for inspection, the gasket must be replaced.

Begin diagnosis by completely cleaning the entire engine and surrounding components. Add GE-28431-6 Black Light Oil Dye to the engine crankcase and run the engine. If necessary, operate the vehicle for several miles at normal operating temperature and at varying speeds to produce the leak. Use the GE-42220 Universal 12V Leak Detection Lamp with the Black Light Oil Dye to isolate the area of the leak.

If the turbocharger oil feed pipe fitting is removed from the engine block for inspection, the fitting and gasket must be replaced.

Retest for engine oil leaks once these components have been replaced to verify the source of the oil leak.
