GM TECHNICAL ASSISTANCE CENTER (TAC)

Dealer Tips and New Information Newsletter

September 16, 2022

1. FAM 0 Engine (RPO LUV) Intake Manifold Redesign Inspection and Familiarization

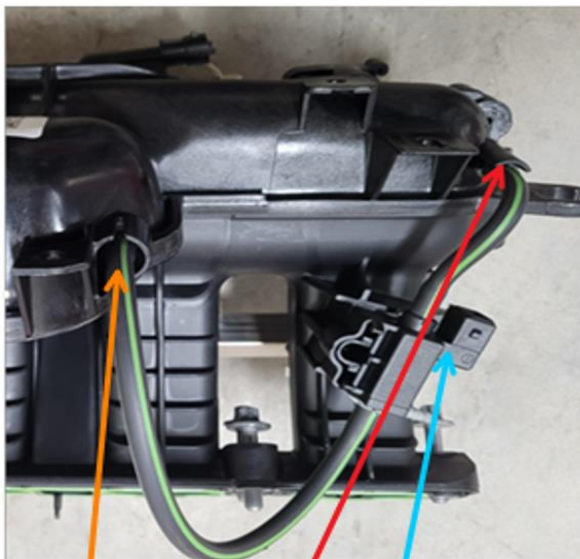
Old Design
 Bypass Valve Vacuum
 Intake Positive Pressure Port
 Solenoid / Electrical connector

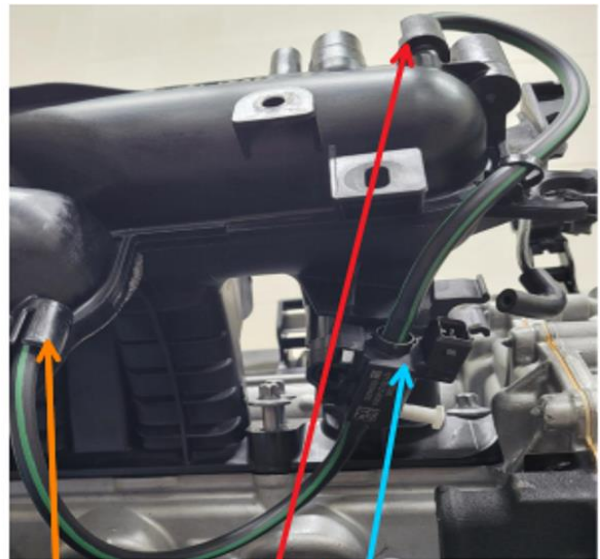
New intake with re-designed Intake Positive Pressure Port Position location. Solenoid location is electrical connector forward. Vacuum feed is in the same location.

If the solenoid is found to be loose, review the location of the electrical connector. If the connector is facing the cylinder head, it is installed backwards and will need to be removed and installed correctly.

New Design
 Bypass Valve Vacuum
 Intake Positive Pressure Port
 Solenoid / Electrical connector
