Checking for Exhaust System Leaks

Checking for Exhaust System Leaks..... 2

GM TechLink is published for all GM retail technicians and service consultants to provide timely information to help increase knowledge about GM products and improve the performance of the service department.

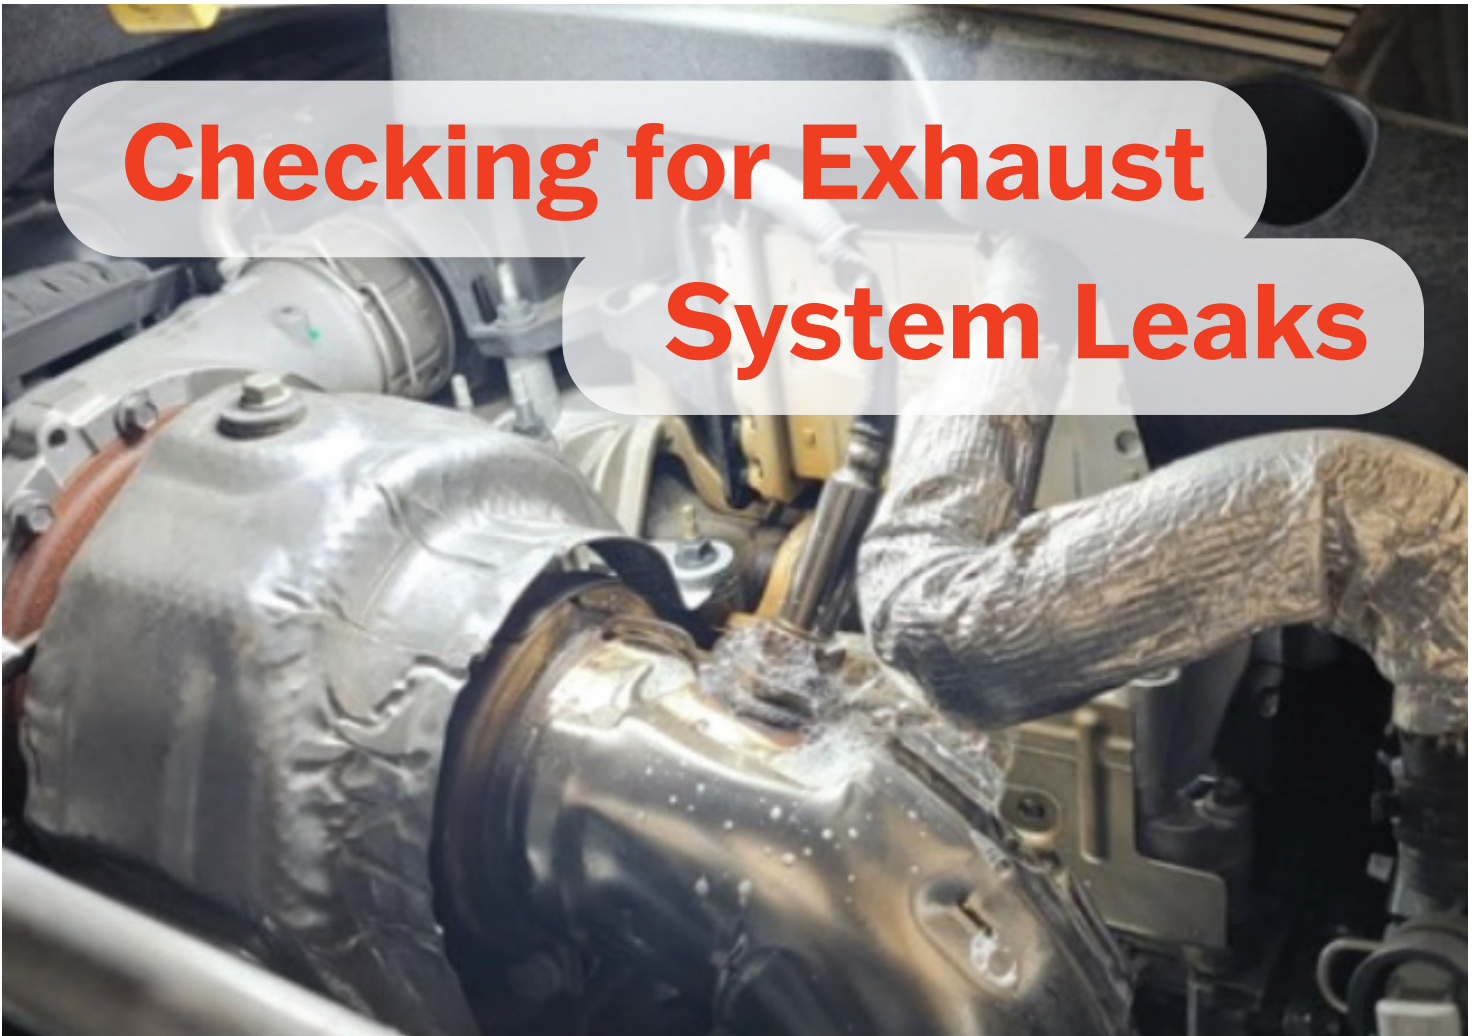
Several DTCs set in the Engine Control Module (ECM) may be caused by an exhaust leak on some 2020-2022 Silverado 1500, Sierra 1500; 2021-2023 Tahoe, Suburban, Yukon and Escalade models equipped with the 3.0L Duramax diesel engine (RPO LM2). The exhaust leak will allow oxygen into the exhaust and result in an incorrect Nitrogen Oxide sensor reading.

- P11D5: Nitrogen Oxides Sensor 2 Exceeded Minimum Learning Limit
- P14D9: NOx Sensor Exceeded Minimum Learning Limit Bank 1 Sensor 3
- P20EE: Nitrogen Oxides Catalytic Converter Efficiency Below Threshold
- P2C7A: Nitrogen Oxides Catalytic Converter 2 Efficiency Below Threshold
- P0421: Catalytic Converter Low Efficiency

To help identify the location of the exhaust leak on the 3.0L diesel exhaust system, perform a leak test using the GE-52250 High Pressure Leak Detector.

Refer to Bulletin #22-NA-168 for details on using the GE-52250 High Pressure Leak Detector to locate the exhaust leak. The cooling ports in the exhaust system must be sealed off before installing the inflatable adapter from the GE-52250 machine.

Once all leaks have been identified and corrections to the exhaust system have been made, verify that the exhaust is sealed by retesting with the GE-52250 High Pressure Leak Detector.

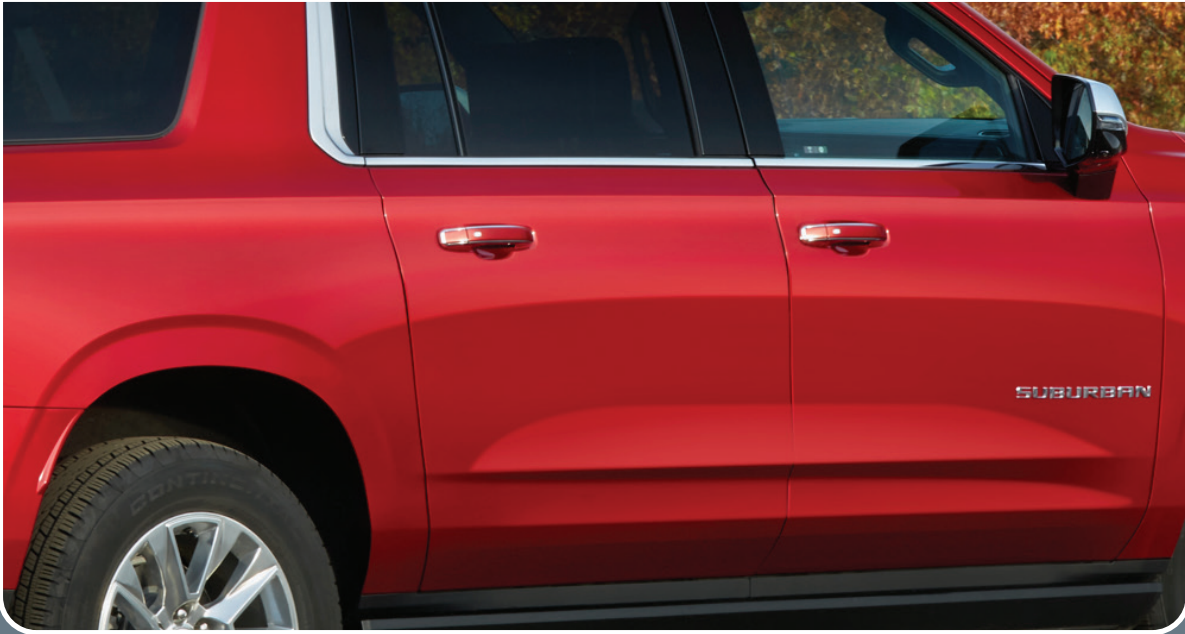
Some 2021-2023 Tahoe, Suburban, Yukon and Escalade models may have a right rear door that requires alignment. If the rear door is not flush or sticks out excessively at the bottom when closed, align the door following the alignment procedure in Bulletin #22-NA-179.
