Power Folding Top Does Not Cycle Completely

**4.2L V8 Fuel System
Components Retrofit
Procedure**

**Incorrect Headlamp
and DRL Operation
Condition**

TECH LINK

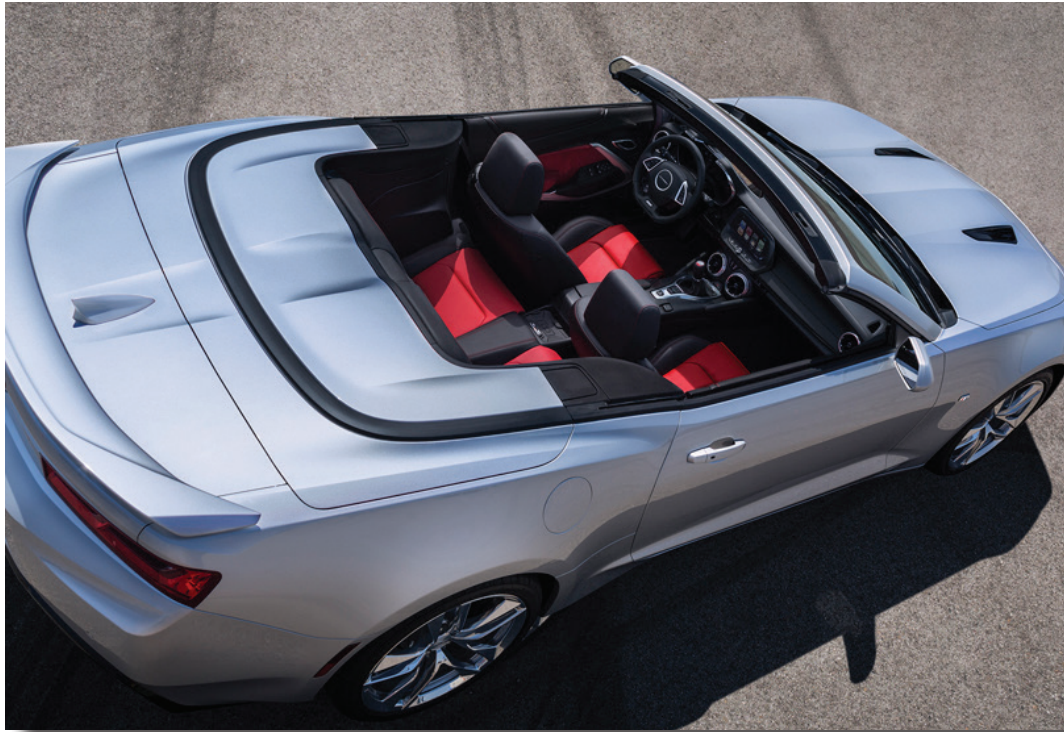
Power Folding Top Does Not Cycle Completely

Some 2016-2023 Camaro convertible models may have a power top (RPO CM8) that does not fully complete the folding cycle. A Top Not Secure message also may be displayed on the Driver Information Center (DIC).

When opening the folding top, the canvas top may stow into the rear compartment, and the tonneau cover (folding top stowage compartment lid) may close. In this case, it appears that everything is in working order. However, the Top Not Secure message is still displayed on the DIC.

These opening and closing conditions may be caused by the B244L/B244R folding top stowage compartment lid position sensors not transitioning correctly when the tonneau cover has closed.

If these conditions are found, check the status of the B244L/B244R Folding Top Stowage Compartment Lid Closed Position Sensors in the scan tool data. Both sensors should read as "On" when the tonneau cover is in the closed position. Regardless of the position of the tonneau cover, both the left and right sensors should always have the same reading — On or Off — as a pair.

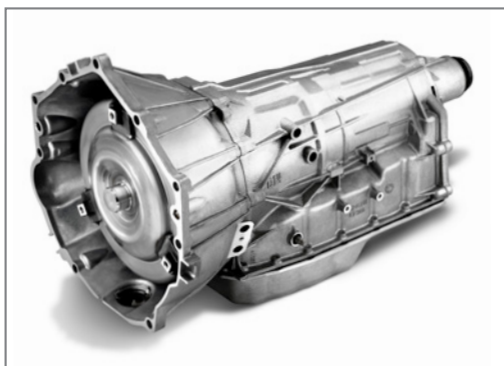
6L90 6-speed automatic transmission

The transmission fluid temperature of some 6L80 6-speed automatic transmissions (RPO MYC) and 6L90 6-speed automatic transmissions (RPO MYD) may be too hot under some operating conditions. Affected models include 2014-2020 Tahoe, Suburban, Yukon; 2014-2021 Silverado 1500, Silverado 2500HD/3500HD, Express, Sierra 1500, Sierra 2500HD/3500HD and Savana.

If the TBV has been replaced, the operating temperature will be lower. The previous TBV had a full-open temperature of 194°F (90°C). The new TBV has a full-open temperature of 158°F (70°C). Refer to Bulletin #21-NA-199 for more information.

A new Thermal Bypass Valve (TBV) for the transmission cooler is available that has a lower operating temperature. The new TBV is available for some 2016-2021

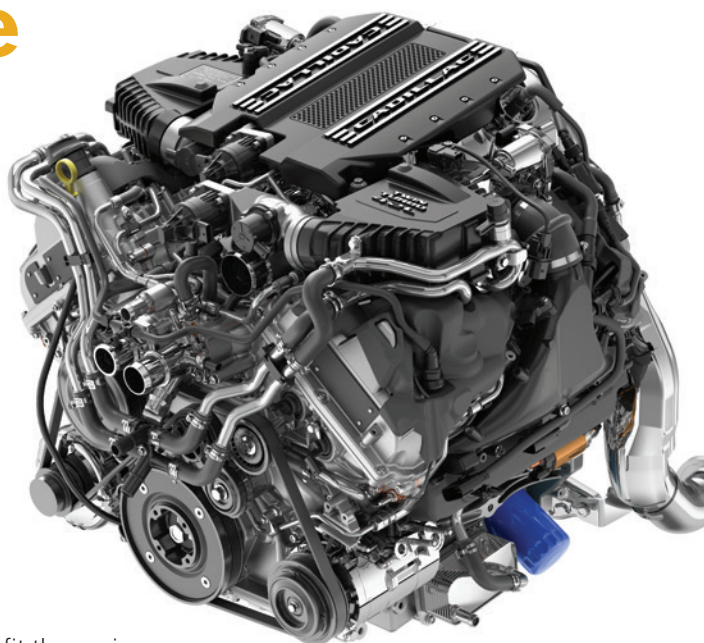
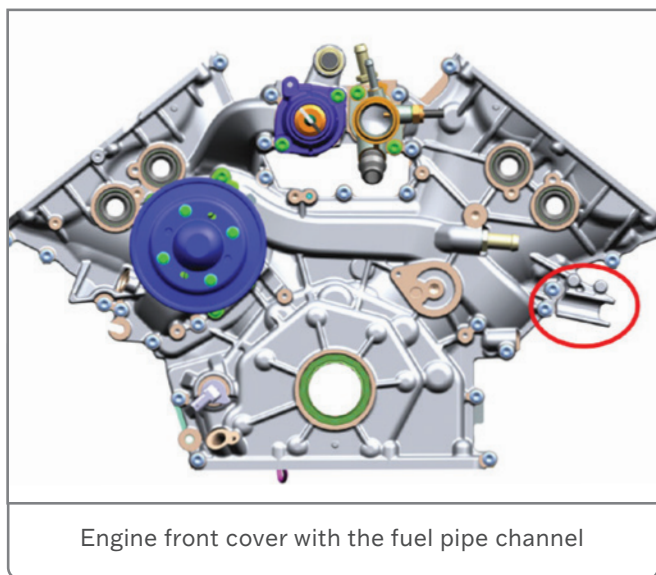
A dimensional change to the fuel feed pipe and fuel rail assembly was made during the 2019 model year, which prompted the release of the 2nd design fuel feed pipe, fuel rail assembly, oil cooler pipe and engine front cover.

The 2nd design fuel feed pipe and fuel rail assembly will not service an engine that was originally equipped with the 1st design fuel feed pipe, fuel rail assembly or engine front cover.

To retrofit the engine to accommodate any of the 2nd design parts, it's necessary to replace the fuel rail assembly, fuel feed pipe and engine oil cooler pipe to completely update the engine to the latest service content.

There were also two designs of the engine front cover in production — one with the fuel pipe channel (shown below) and one without. Before ordering parts, determine which front cover is needed. If the engine has the 1st design front cover with the fuel pipe channel, order a new engine front cover to complete the repair. If the front cover does not have the fuel pipe channel, do not replace the engine front cover.

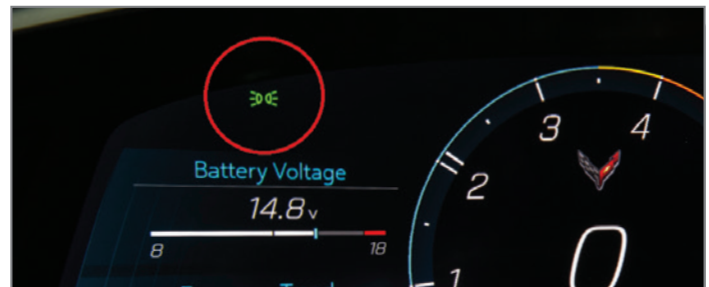
The headlamps may be turning on automatically during daylight conditions instead of the Daytime Running Lamps (DRL) on some 2022 Tahoe, Suburban, Yukon, Escalade and 2022-2023 Corvette models. DTC B108E (Ambient Light Sensor Signal) also may be set.

For 2023 model year Corvettes with the headlamp operation condition, updated software may not be available yet. For these vehicles, it is recommended to check the headlamp switch setting and for an illuminated Lights On Reminder symbol on the instrument cluster to ensure the headlamps are on when driving in low lighting conditions.
