**TECH LINK** 2023

# Incorrect Tire Size

## May Lead to Damaged Fuel Pump Harness

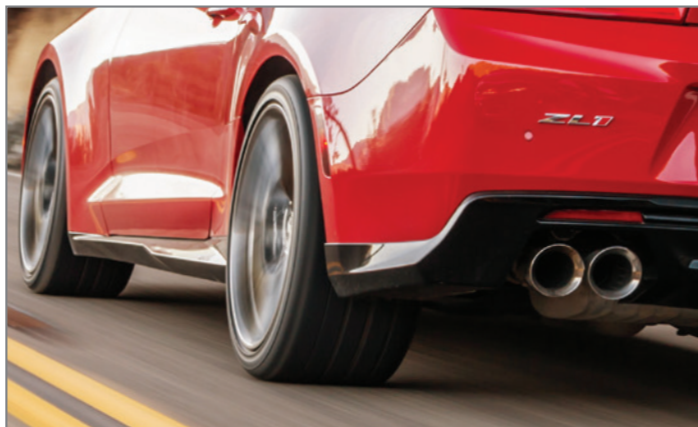
An extended engine crank or reduced engine power condition may be the result of incorrect tires mounted on some 2016-2023 Camaro SS, Camaro SS 1LE (RPO A1Y); 2017-2023 Camaro ZL1; and 2018-2023 Camaro ZL1 1LE (RPO A1Z) models.

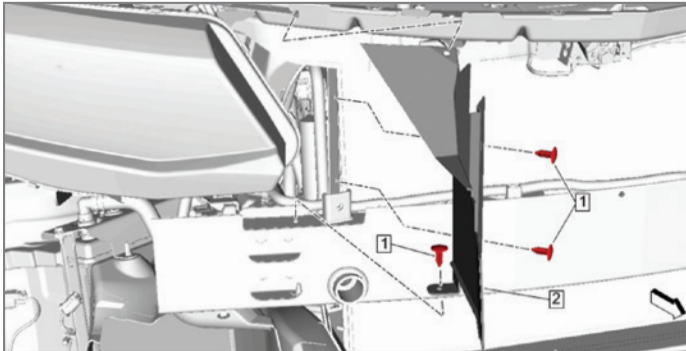
A squeak sound may be heard coming from the front of the vehicle on some 2019-2023 Camaro models equipped with the 2.0L I4 turbo engine (RPO LTG) or the 3.6L V6 engine (RPO LGX). The sound emanates from the passenger's side of the vehicle while driving over bumps. It also may be more noticeable once the engine has reached normal operating temperature.

The squeak sound on these engines may be caused by the radiator air baffle on the right side of the vehicle contacting the core support.

Radiator air side baffle
