New System Reset and Connector Reconnect Labor Codes

DTC Sets After Turbocharger Replacement

Maintaining Power to a Module Sent in for Warranty Analysis

Sticking Charge Air Bypass Valve

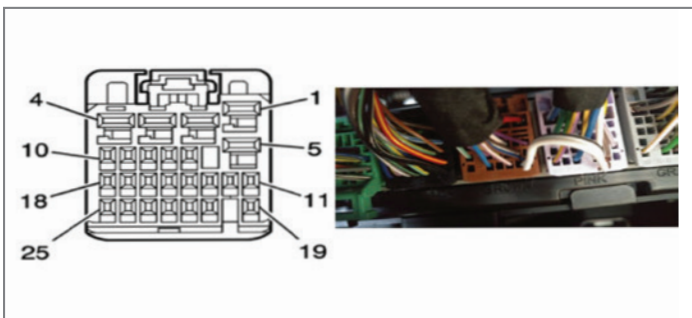
Identify the (-) Ground and (+) 12V power supply terminals

Use Service Information schematics connector end views to find the component's pinout to identify the (-) Ground and (+) 12V power supply terminals. If there is more than one, confirm with

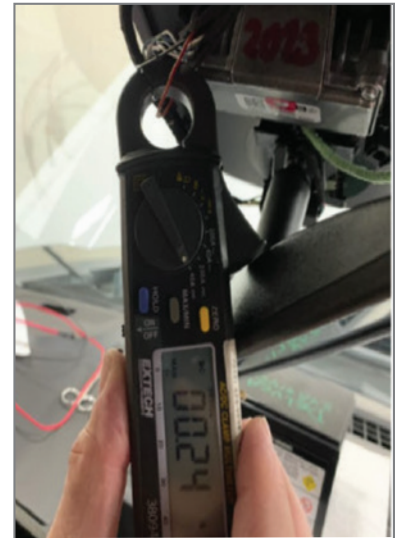
Again, if the module harvesting concerns a parasitic drain, verify that the drain is still present using a current clamp once it has been removed from the vehicle.

Verify the drain is still present before securing the connection.

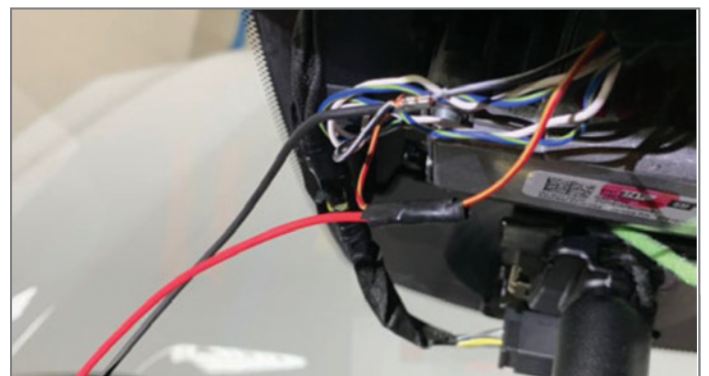
Ground and 12V wires connected to the battery.

Once the ground and 12V wires to the battery are connected, cut the wires on the connector one at a time to remove the battery and component out of the vehicle.

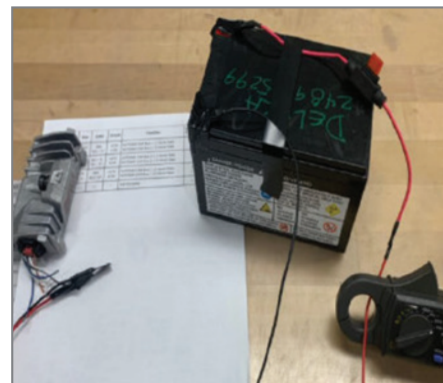
Module removed from the vehicle with battery connection.

When returning the component in the failed state, firmly secure the battery and component in the shipping container to ensure the electrical connection stays secure. Also properly seal and package the component in the shipping container and label the package: UN2800 – Batteries, Wet, Non-spillable.
