## Latest Techline Connect Tips Shared by the TCSC

**The Techline Customer Support Center (TCSC) has released their latest tips for Techline Connect and the Service Programming System.**

# Transfer Case Actuator Alignment

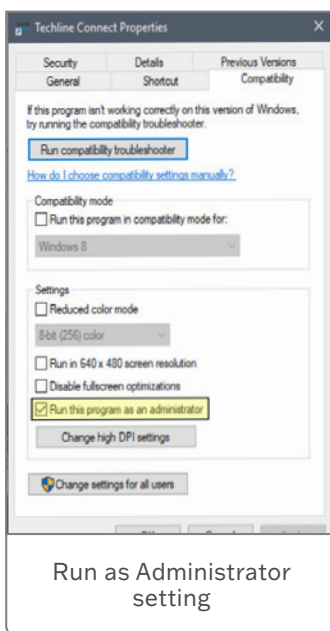
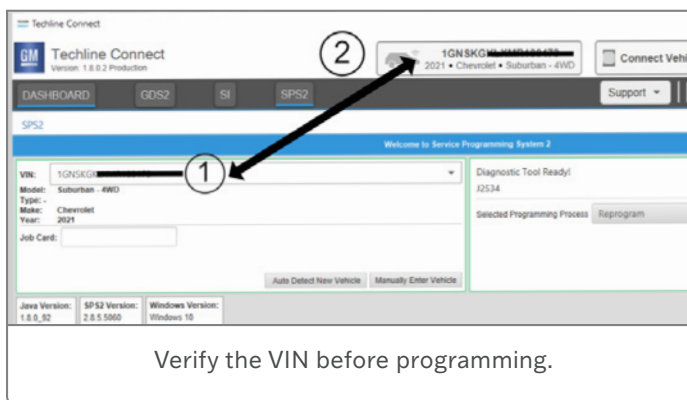
Technicians can manually enter the VIN for a vehicle being serviced via "Select Vehicle," followed by entering the VIN on the left side of the TLC screen. Always verify that the VIN displayed in the TLC left-side drop-down menu and the top-center window match the VIN plate of the vehicle to be programmed prior to using Service Programming System 2 (SPS2) for programming or reprogramming a module.

For the TLC application, make sure that the power mode (ignition) is ON before reading the VIN from the vehicle's VIN master module and that a VIN that is already in the TLC application memory from a previous vehicle is not selected.

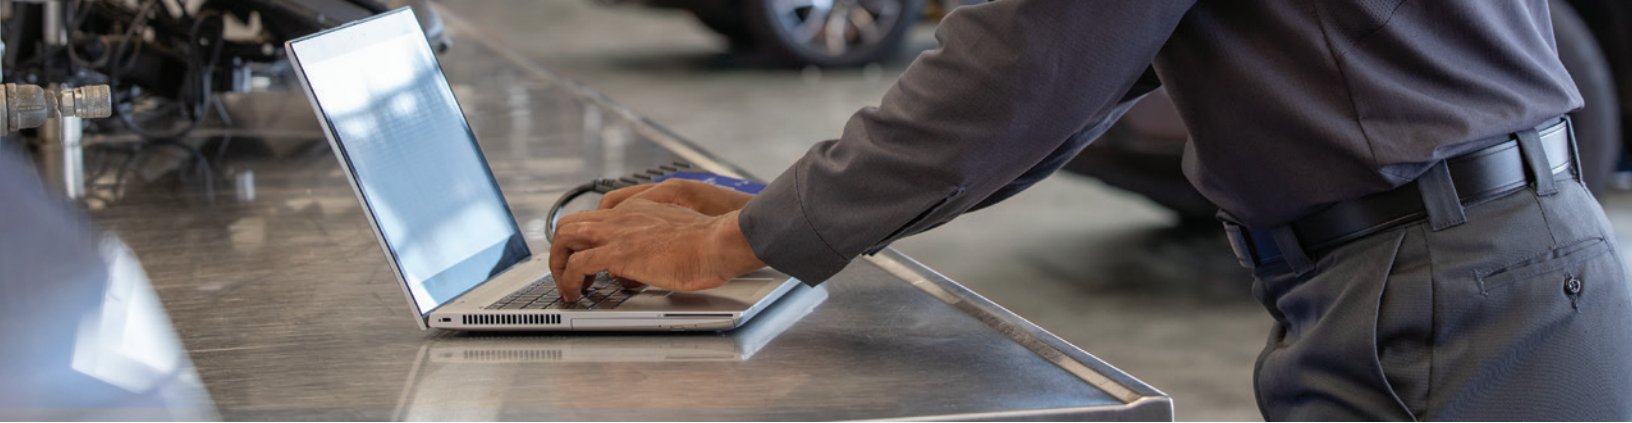
TLC implemented a change that has SPS2 always check that the VIN that TLC is set to matches the VIN read from the VIN master module (for example, the ECM for VIP vehicles). This is to address the potential for an incorrect VIN being set in TLC. If the vehicle VIN does not match, a warning message will be shown.:
