Communication DTCs Set ON 3.0L DURAMAX DIESEL ENGINE

Communication DTCs Set on 3.0L Duramax Diesel Engine

TECH LINK

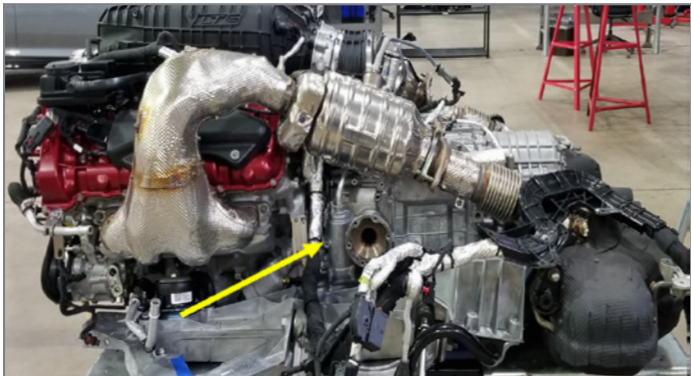
The Tremec DCT TR9080 dual clutch transmission (RPO M1L, M1M) on 2020-2023 Corvettes features a transmission canister filter that should be replaced at the initial 7,500-mile (12,000-km) maintenance service and at regular intervals. The canister filter change in the first 7,500 miles (12,000 km) is critical due to the initial break-in of the internal transmission components.

Transmission canister filter

GM has extended maintenance coverage of the filter to two years or 7,500 miles (12,000 km), whichever comes first, on the first filter change to cover vehicles that do not accumulate 7,500 miles in the first year. It is recommended to only replace the filter at the required maintenance intervals due to the loading characteristics of the filter.

Recommended miles intervals should be followed. If a customer elects to have the filter changed before 7,500 miles (12,000 km), it should be changed again at 7,500 miles (12,000 km). Check the maintenance schedule in the appropriate Service Information.

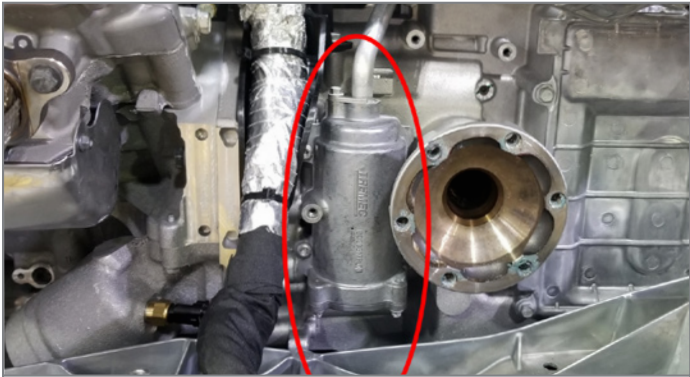
The initial filter change should be at 7,500 miles (12,000 km).

The initial filter change should be at 7,500 miles (12,000 km) and then at 22,500-mile (36,210-km) intervals.

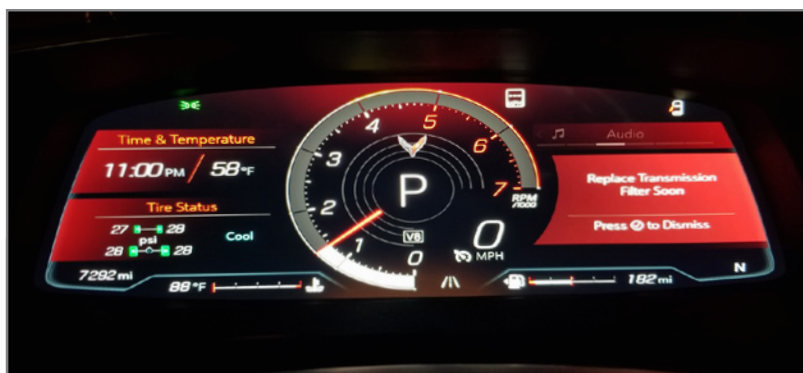
The 2023 Corvette features a new maintenance minder on the Driver Information Center and will display a maintenance message shortly before the 7,500-mile (12,000-km) maintenance interval. The message will appear every 22,500 miles (36,210 km) after the first maintenance service is performed. The transmission filter minder cannot be reset like the engine oil life monitor.

2023 Corvettes feature a maintenance minder for the transmission filter.

If the transmission is replaced, customers will need to keep track of the mileage, starting with the first 7,500 mile (12,000 km) maintenance service for the new transmission.

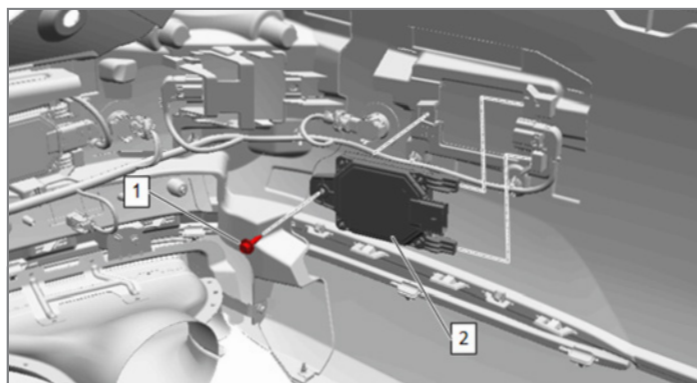
Short Range Radar Rear Side Sensor

After a rear side SRR module has been replaced, the Side Blind Zone Alert (SBZA) indicator may not illuminate in the side mirrors when the customer drives past a vehicle. However, the alert indicator will illuminate when another vehicle is passing the customer. This condition will only be present after an SRR module is replaced using part number 84907387.

To address the Side Blind Zone Alert indicator condition, the system should be reset. On the infotainment screen, go to Settings > System > Return to Factory Settings.

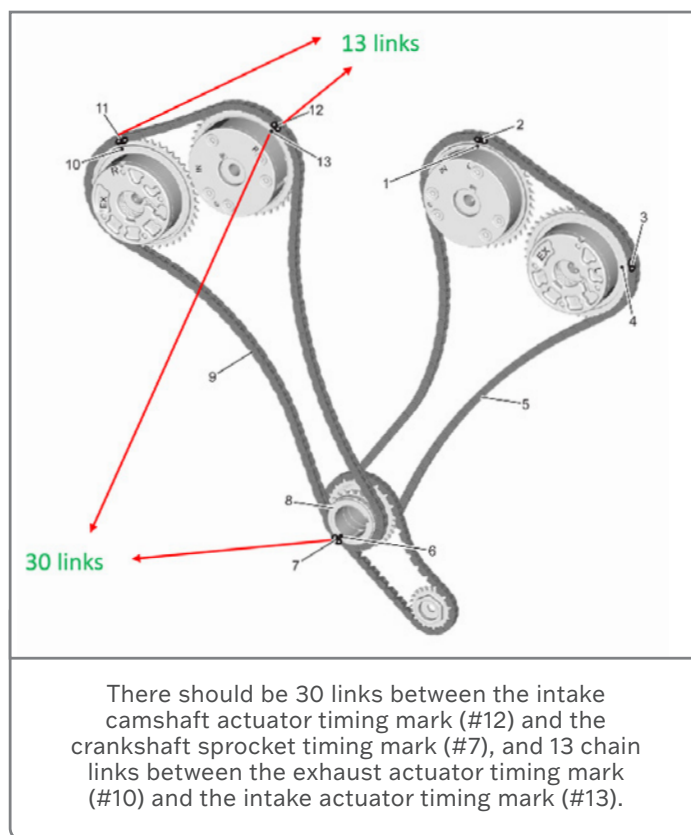
There should be 30 chain links, including the links on the timing marks, between the intake camshaft actuator timing mark (#12) and the crankshaft sprocket timing mark (#7).

There also should be 13 chain links, including the links on the timing marks, between the exhaust actuator timing mark (#10) and the intake actuator timing mark (#13).

To verify correct Stage 2 timing:

1. Put the crankshaft keyway at the Stage 2 (3 o'clock) position.
2. Count the links between the intake actuator timing mark and the crankshaft timing mark. It should be 30 links.

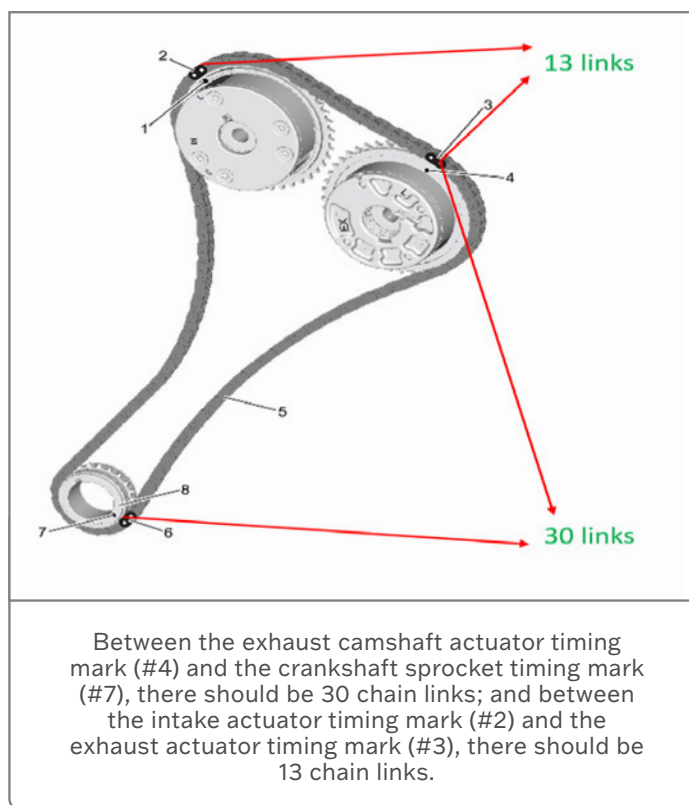
Between the exhaust camshaft actuator timing mark (#4) and the crankshaft sprocket timing mark (#7), there should be 30 chain links, including the links on the timing marks.

Between the intake actuator timing mark (#2) and the exhaust actuator timing mark (#3), there should be 13 chain links, including the links on the timing marks.

To verify correct Stage 1 timing:

1. Remove the Stage 2 chain and crank sprocket.
2. Remove the oil pump chain and crank sprocket.
3. Put the crankshaft keyway at the Stage 1 (11 o'clock) position.
