Active Grille Shutter Front-End Noise

Active Grille Shutters Front-End Noise

TECH LINK

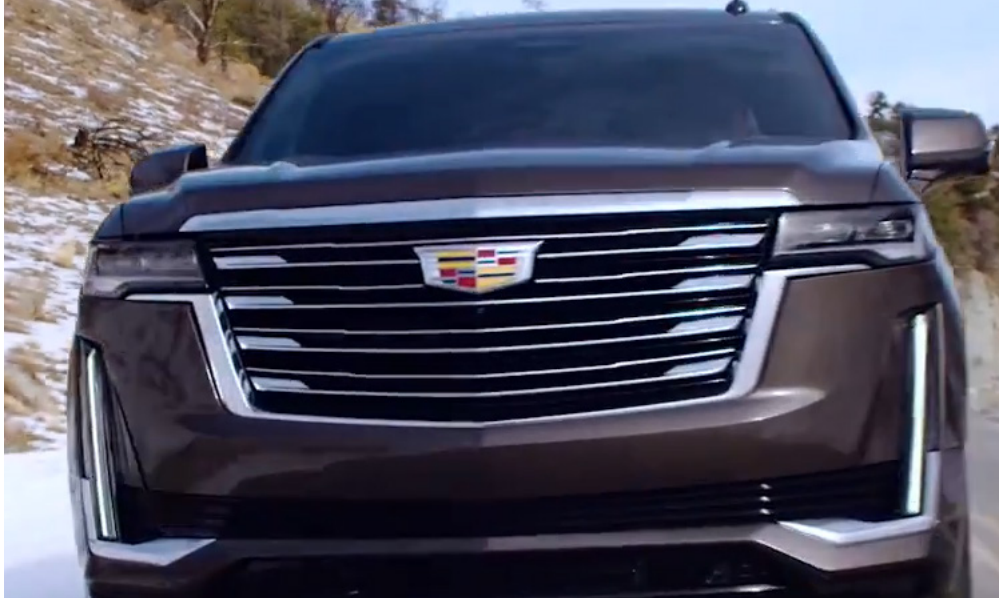
Some 2021-2023 Escalade, Silverado, Tahoe, Suburban, Sierra and Yukon models may be producing a thump, clunk, pop or click noise at the front end of the vehicle. The sound also may be felt in the brake pedal or on the floor in the front of the cabin. The condition typically occurs after the vehicle has been driven at least 45 mph (72 km/h) and then comes to a stop, or after the brake pedal is released after a stop.

The front-end noise condition may stem from road debris or a component coming in contact with the active grille shutters as they open and close.

Possible items, such as road debris, stones, ice, or a mispositioned horn bracket or unsecured intake air duct, may be contacting the shutters and causing the noise.

To help determine the cause of the noise, with the shutters open, remove the fuse that powers the active grille shutters actuator. With the fuse removed, test the vehicle to see if the noise still occurs.

If the noise is not present, remove the intake air splash shield and inspect the active grille shutters for any items that may be making contact.

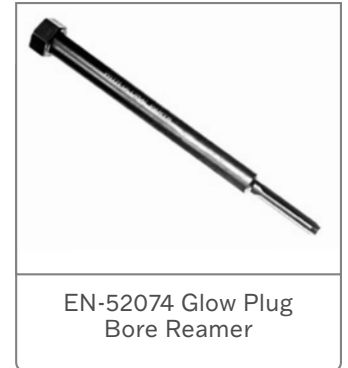
As the engine runs during normal operation, soot builds up between the outside of the glow plug and the inside of the glow plug hole. Once a glow plug is removed, this soot that collected in the bore must be removed. If the soot is not removed before installing a new glow plug, the soot could "side load" the new glow plug and induce a premature failure.

With grease applied to the Glow Plug Bore Reamer to catch any carbon removed, it pilots into the glow plug bore and the reamer end passes into the combustion chamber of the head. The hex on Glow Plug Bore Reamer is turned with a ratchet to remove any carbon build up, which remains in the grease on the end of the tool.

The recommended tool for cleaning the glow plug holes on the 1.6L, 3.0L and 6.6L diesel engines is the EN-52074 Glow Plug Bore Reamer.

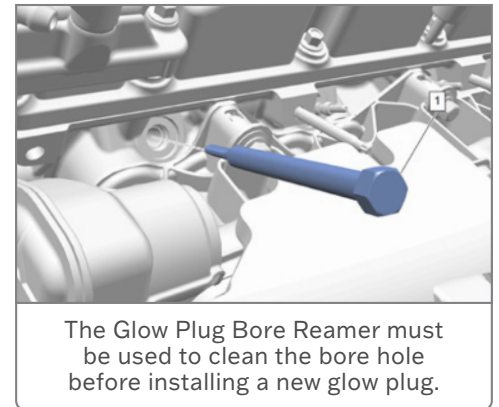
Before cleaning the glow plug bore, inspect each removed glow plug to ensure it is fully intact and not broken. If a broken glow plug tip is found, inspect the combustion chamber for the tip or any debris.

After replacing the glow plugs on the 6.6L diesel engine, the glow plug learn procedure should be performed to enable the Glow Plug Control Module to relearn the values of the plugs.
