# USING THE COAX FAKRA Cable Adapter Kit

New Design Intake Manifold Addresses Poor Engine Performance

GM TechLink is published for all GM retail technicians and service consultants to provide timely information to help increase knowledge about GM products and improve the performance of the service department.

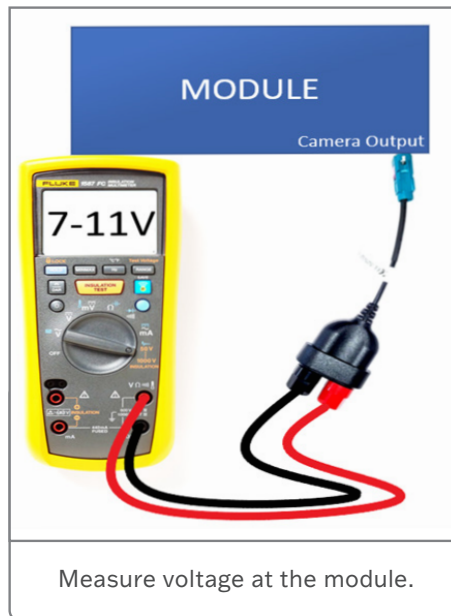
1. The first step is to disconnect the inoperable camera at the module. The K157 Video Processing Module can be found in vehicles equipped with Surround Vision Camera System (RPO UV2, UVS) or Trailer Camera System (RPO UVI). Vehicles with the A11 Radio will be equipped with the Rear Vision Camera System (RPO UVB).

2. With the ignition On, measure the voltage at the module.
3. If voltage is not between 7 and 11V, the module should be replaced.
4. If the voltage is between 7 and 11V, disconnect the camera that is inoperable.

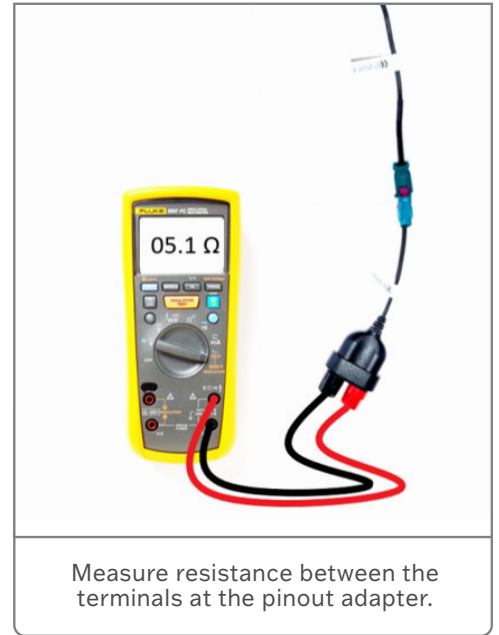
5. Find the appropriate pinout adapter and load test loop adapter from the EL-52552 COAX FAKRA Cable Adaptor Kit.

6. Connect the two adapters together and measure the resistance between the terminals at the pinout adapter.

Record the resistance for later use.

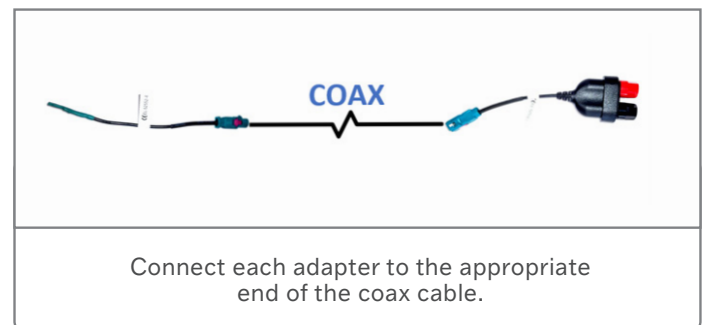
7. Disconnect the two adapters and connect each one to the appropriate end of the coax cable.
8. At the pinout adapter test terminals, measure the total resistance of the coax cable loop, including the connected load test adapter. If the resistance is not within 5Ω of the reading taken in Step 6, replace the coax cable. If the resistance is within 5Ω of the reading taken in Step 6, replace the camera.
9. Reconnect all connectors and check if any DTCs are set.
10. If a DTC is set, the module may need to be replaced.

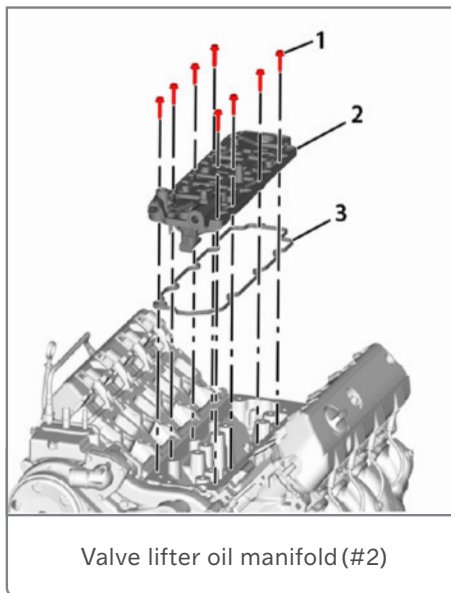
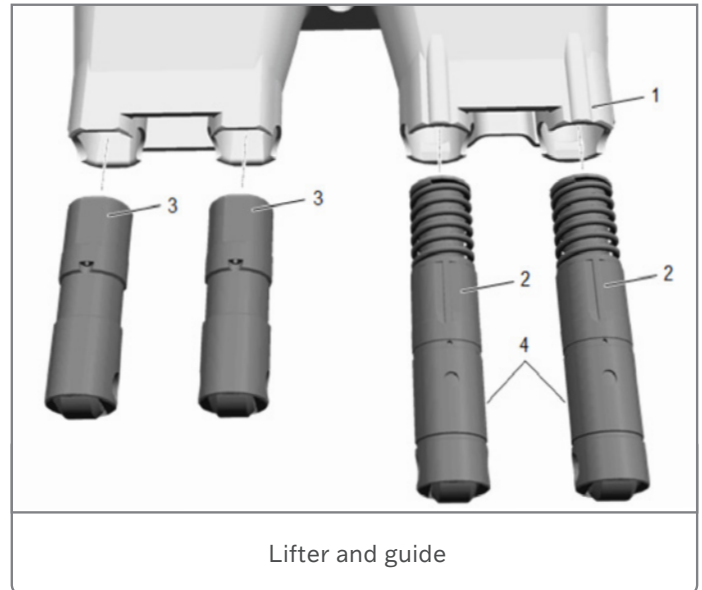
Possible causes of the misfire condition include an Active Fuel Management (AFM) lifter that is mechanically collapsed and/or stuck all of the time, internal locking pin damage in the lifter due to oil aeration, a collapsed lifter that is stuck in the lifter bore, or a bent pushrod.

During diagnosis, inspect the valve operation. If the valves are not moving, it may be necessary to replace the valve lifter oil manifold and the affected bank of AFM lifters. If the lifter has spun the bore, the guides also should be replaced.

The part numbers have been updated for the individual components that were previously included in the valve lifter oil manifold (VLOM) kit. With the updated part numbers, select only the parts that coincide with the repair being performed. The VLOM should be replaced only if it tests faulty.

If a lifter is stuck in the bore, use vice grips with a slide hammer or a small pry bar to remove the lifter. Do not pry on the sealing surface of the block when removing a lifter.

**TIP:** Any time a lifter is replaced, the lifter guide also must be replaced.

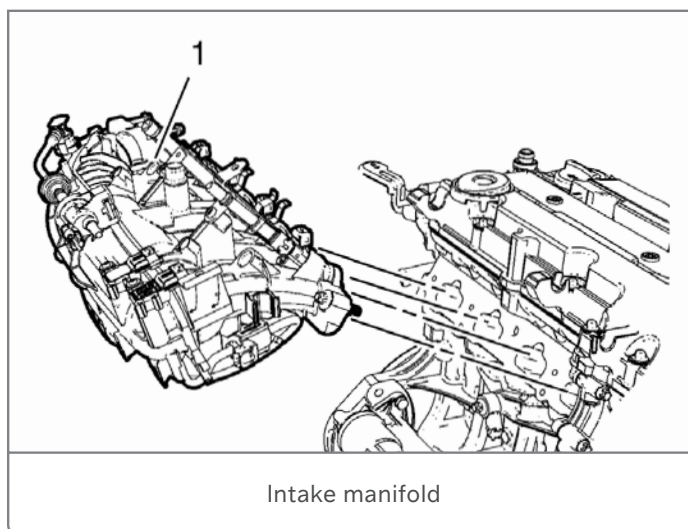
If the performance and drivability issues are present, check for a restricted flow through the bypass solenoid, moisture from the intake vacuum reservoir accumulating and damaging the bypass solenoid, contamination such as ice, water, oil or sludge at the charge air bypass valve, ice accumulation in the intake manifold blocking the PCV passage in the cylinder head, ice accumulation in the charge air cooler restricting air flow to the throttle body and ice plugging the crankcase vent tube during very cold weather conditions.

If contamination is found at the charge air bypass valve, disassemble and clean the charge air bypass valve and replace the intake manifold with the updated design part. Vehicles with the old design intake manifold should have the updated design intake manifold installed. In addition, replace the charge air bypass valve if necessary.

Inspect the charge air bypass valve for ice, water, oil or sludge build-up in the vacuum side port. If there is only oil or water build-up in the valve port, disassemble and clean the components. Replace the components only if necessary.
