Testing for Diesel Fuel System Contamination

TECH LINK

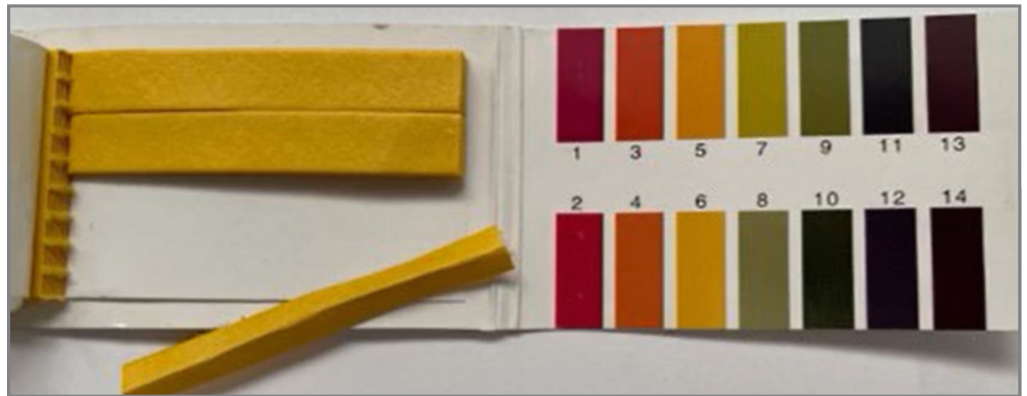
Litmus paper and pH scale

If the litmus paper shows a pH level of approximately 10–11, it is likely DEF. Compare the sample with a strip of litmus paper inserted into pure DEF to confirm. If there is DEF contamination, and the engine has been cranked, the entire fuel system from the fuel fill pipe to high-pressure fuel pump, fuel rail, injectors, injector return fuel lines, high-pressure fuel pipes and low-pressure return lines must be replaced. For complete information on addressing fuel system contamination, refer to Fuel System Cleaning in the appropriate Service Information.

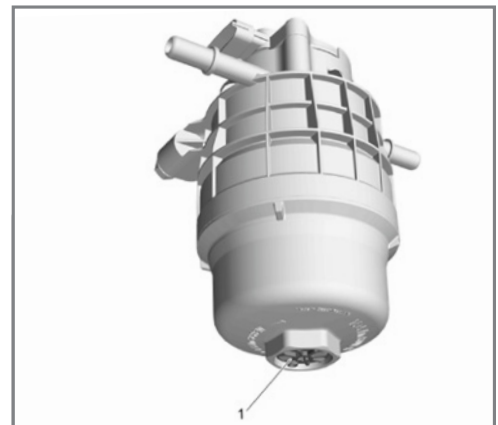
Fuel filter drain plug (#1)

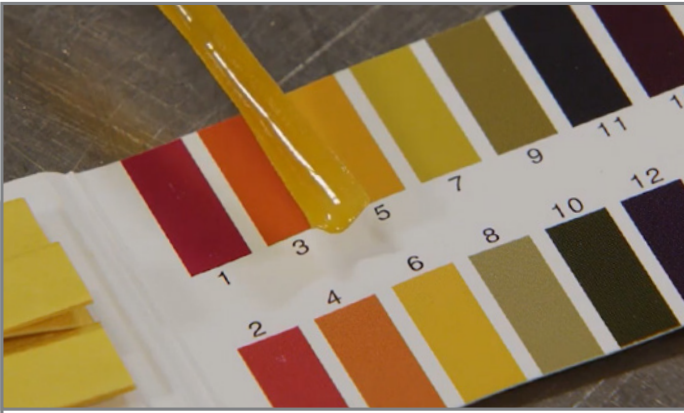
Uncontaminated diesel fuel

Remember, diesel fuel has a pH level of 5, so there should not be much change seen in a mixture of diesel fuel and water. If the fuel system is contaminated with water, inspect the fuel system components for rust or deterioration.
