Engine Performance in Extremely Cold Weather Conditions

TECHLINK

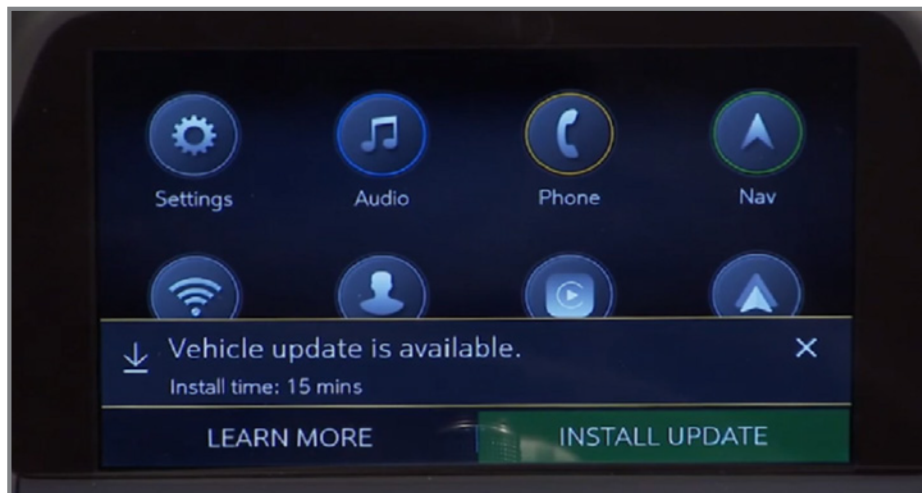
When an Over-the-Air (OTA) update has been downloaded to a 2021-2024 Chevrolet, Buick, GMC or Cadillac vehicle and is available to be installed, a message is displayed on the infotainment screen notifying the driver of the impending update. The message to accept and install an OTA update will not appear until the minimum values for the battery State of Charge (SOC) and Outside Ambient Temperature (OAT) are met.

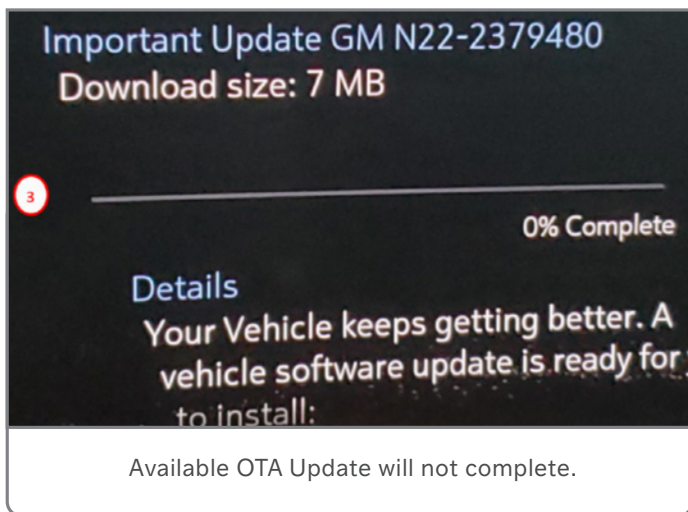
- Radio remains on for up to 11 minutes after Retained Accessory Power (RAP) is cancelled.
- No crank condition due to a dead battery. The vehicle will start and run after the battery is charged.
- Intermittent condition at start-up where the infotainment screen momentarily displays “Important Update ... Download Resuming”:
- Vehicle Update screen shows OTA Update failure or that the available OTA Update will not complete.

These concerns may be the result of the OTA update being stuck in a pending or download state.

Perform the following items to reset the OTA Update and clear the messages:
