Mid-June 2023, Volume 25, No. 12

| Meet the New Buick Envista1 |
|---|
| Upfitter Auxiliary Switch LED Indicators4 |
| Maintaining Seat Belt and Retractor Guide Cleanliness5 |
| Clean Head Bolt Holes Before Cylinder Head Installation6 |

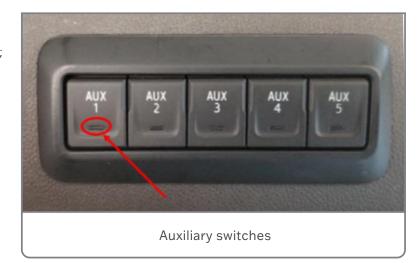
The LED "on" indicators on the upfitter auxiliary switches (RPO 9L7), located on the instrument panel, may not illuminate properly on some 2023 Silverado 1500, Sierra 1500; 2024 Silverado 2500/3500 and Sierra 2500/3500 models.

With only one auxiliary switch on, the LED indicator may illuminate. However, if more than one switch is turned on, the LED indicators will not illuminate

Regardless of how many auxiliary switches are turned on, the auxiliary switches will operate the auxiliary equipment. Only the "on" indicators on the switches are affected by this condition. Do not replace any components or auxiliary equipment.

If the auxiliary switches are not illuminating correctly, reprogram the Body Control Module (BCM) with the latest calibrations.

Refer to #PIT6040 for additional information.
