Corvette Transmission Canister Filter

Corvette Transmission
Canister Filter and Maintenance
Information..... 2

TECH LINK

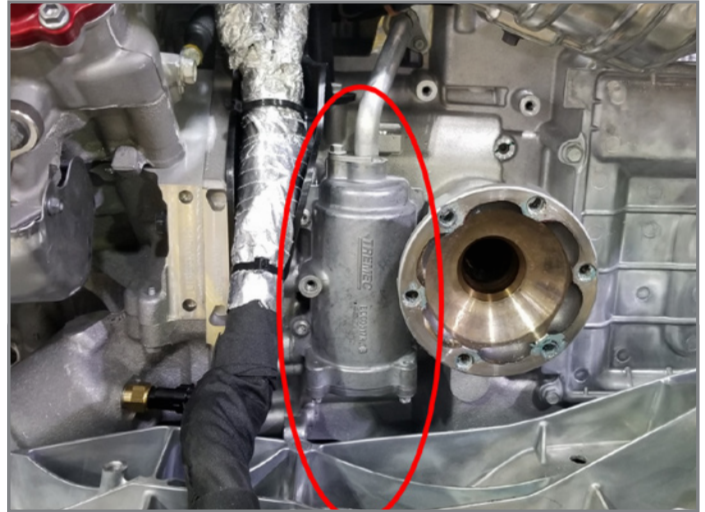
Transmission canister filter

The initial filter change should be at 7,500 miles (12,000 km).

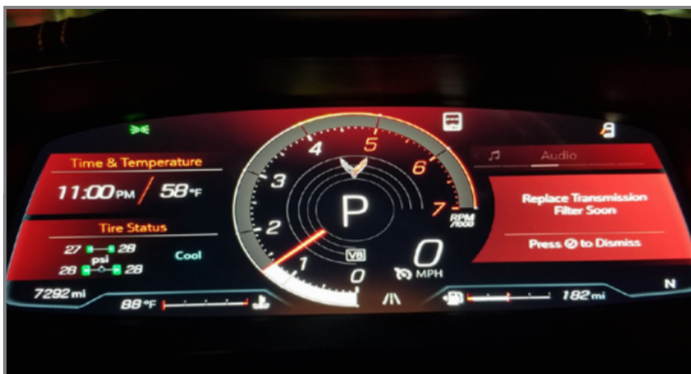
2023 Corvettes feature a maintenance minder for the transmission filter.

Beginning with the 2023 model year, the Corvette has a maintenance minder on the Driver Information Center that will display a maintenance message shortly before the 7,500-mile (12,000-km) maintenance interval. The message also will appear every 22,500 miles (36,000 km). The transmission filter minder cannot be reset like the engine oil life monitor.

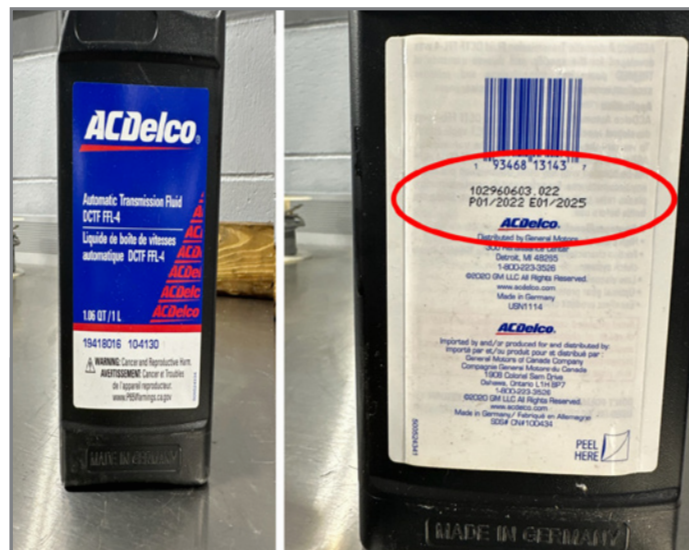
The fluid has a shelf life in the bottle of three years.

The DCTF FFL-4 C8 Corvette transmission fluid should always be shaken vigorously prior to adding fluid to a vehicle in order to disperse the additives throughout the fluid. The fluid has a shelf life in the bottle of three years.

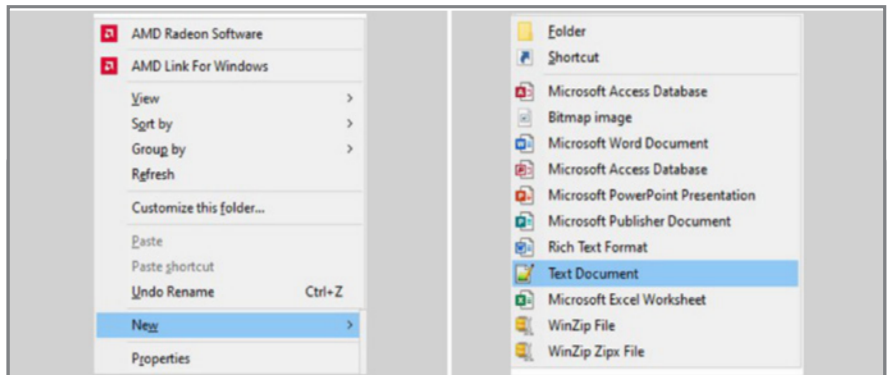
A software update to address the battery check condition during USB programming is currently being developed. The battery check condition does not affect OTA updates.

Create a new text document on the USB drive

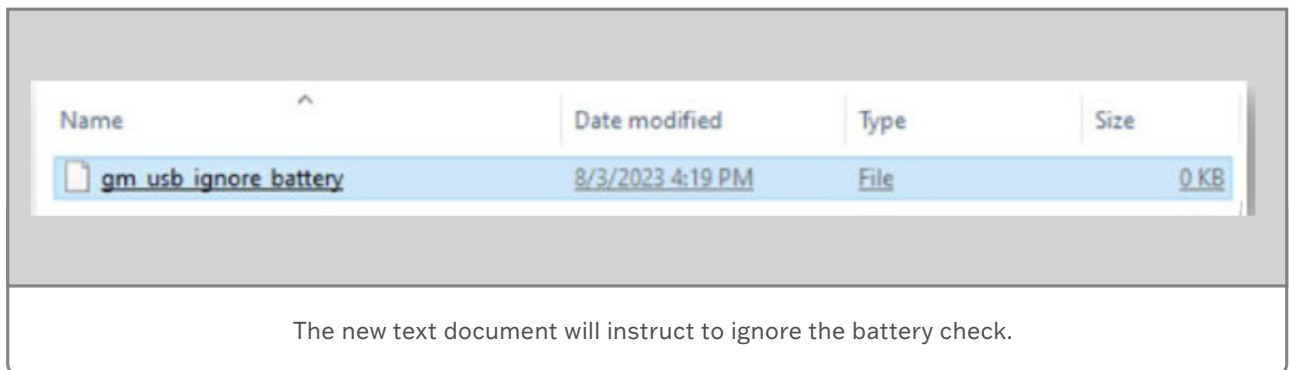
The new text document will instruct to ignore the battery check.

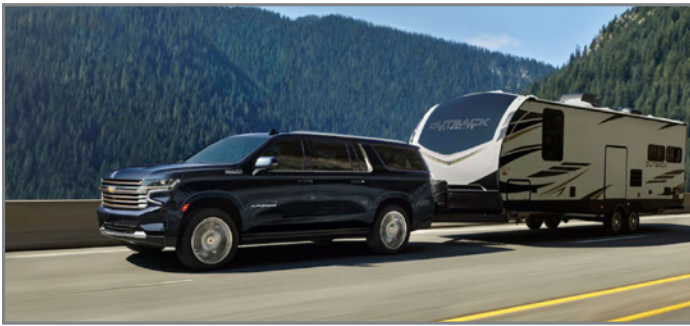
The trailer brakes may become disabled while pulling a trailer on some 2023 Colorado, Tahoe, Suburban, Silverado 4500/5500, Canyon, Yukon, Escalade; 2024 Silverado 2500HD/3500HD, Silverado EV, Sierra 2500HD/3500HD and HUMMER EV models due to a trailer battery condition. DTC C1114 (Trailer Brake Control Solenoid Valves Control Circuit) may be set and a Service Trailer Brake System message may appear on the Driver Information Center.

The trailer brakes may be disabled if the customer's trailer has a solar panel battery charger or generator. If the trailer's battery becomes fully charged and has a higher charge than the vehicle's battery, it can feed back into the trailer brake control module, causing it to shut down.

Anytime the vehicle's battery state of charge is lower than the trailer's battery, this condition may occur. Once the vehicle's charging system brings the vehicle's battery up to a higher state

of charge, the condition should no longer occur and the trailer brakes will work as normal.

If diagnosis shows the trailer brake is disabled, replace the trailer brake control module. An updated part is available. Refer to Trailer Brake Control Module Replacement in the appropriate Service Information.
