M1L Dual Clutch Transmission Case

Design Update

TECH LINK

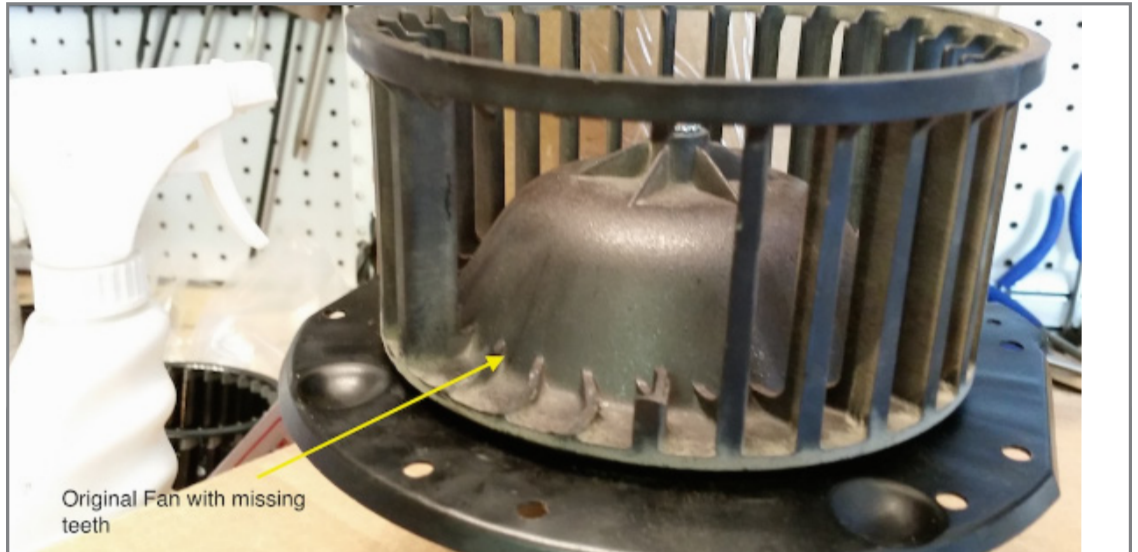
It's critical that the parts arrive at the WPC in the same condition as removed from the vehicle. Missing or broken teeth on a fan, for example, is a common occurrence of damage that occurs during shipping.

Proper packaging helps avoid shipping damage.

When returning parts under warranty, dealerships are strongly encouraged to use the original packaging and packaging orientation of the new part whenever possible to ship back the failed part (see below for an example). The original packaging will help to properly protect the part during shipment.
