# Front Fascia and Headlamp Adjustment

# High Resistance in Ground Straps

# Unable to Complete Transmission Park Lock Position Sensor Measurement

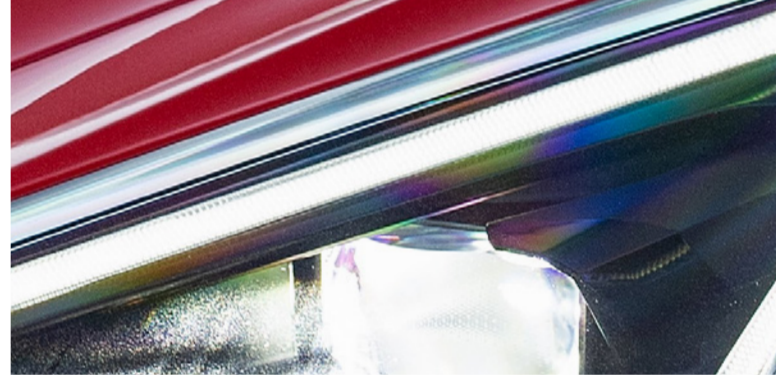
The paint may have chipped or peeled on the front fascia or fender-to-fascia body seam on some 2020-2024 Corvettes. The paint chip may be due to the headlamp being positioned too tightly to the body panel. The fit between the front fascia and fender also may be too tight on the same vehicle.

If these conditions are found, there are four potential high-contact areas where the paint may chip or peel:

1. Fender/fascia under the headlamp
2. Front corner of the headlamp to the fascia
3. Headlamp tight to fender
4. Front fascia to fender

Check for the correct headlamp position before and after any repairs. The headlamp lens should have a minimum 0.5 mm (0.02 in.) gap between the lens and the body panel.

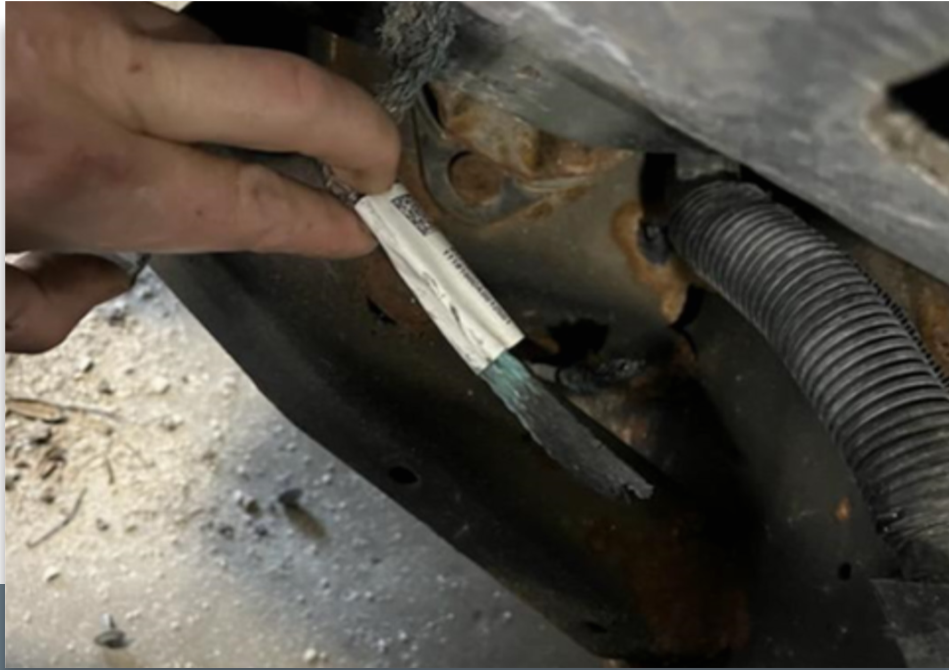
There may be high resistance in the G132 and G133 grounds, located behind the right-hand wheelhouse liner on some 2019-2022 Silverado 1500 and Sierra 1500 models. As a result, a loss of power steering assist or power braking assist may occur.

DTCs B127B (Rearview Camera Input Signal Circuit), B1325 (Control Module Power Circuit), B3205 (Driver Window Motor), C116C (Front Brake Pad Wear Signal Circuit), C1595 (Trailer Brake Signal to Trailer Brake Power Control Module Circuit), P25A2 (Brake System Control Module 1 Requested MIL Illumination), U0420 (Invalid Data Received from Power Steering Control Module) and/or U0422 (Invalid Data Received from Body Control Module) may be set.

If these conditions are found, inspect the G132 engine ground strap and G133 frame ground strap for high resistance and repair as necessary. Check for any loose, stripped or corroded straps or connections. Refer to Ground Repair in the appropriate Service Information.
