Wheel Drive Shaft Damage

Shift Concerns on 8-Speed Transmissions

TECH LINK

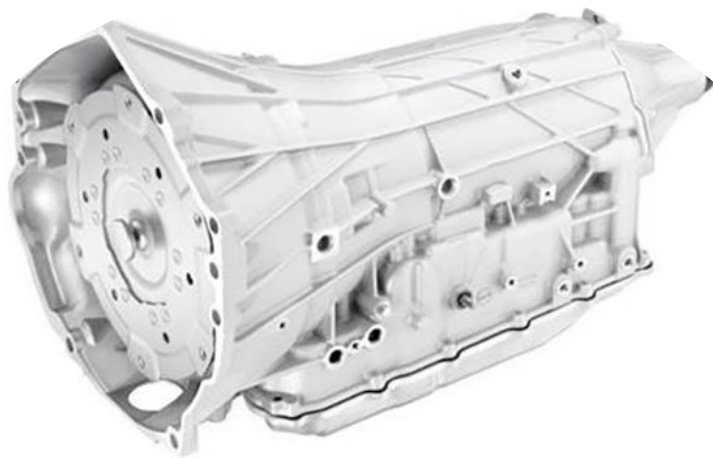
The 8-speed automatic transmissions (RPO M5N, MNU, M5U, M5X, MHA, M5T, MQE, MQD) in some 2015-2018 Corvette; 2015-2020 Escalade, Yukon; 2015-2023 Silverado 1500, Sierra 1500; 2016-2018 CTS; 2016-2019 ATS, CTS; 2016-2023 Camaro; 2017-2023 Colorado, Canyon; 2017-2024 Express, Savana; and 2020-2024 CT4 models may exhibit hard or harsh shifts.

There are several steps that should be taken to improve the shift quality, depending on the mileage on the vehicle.

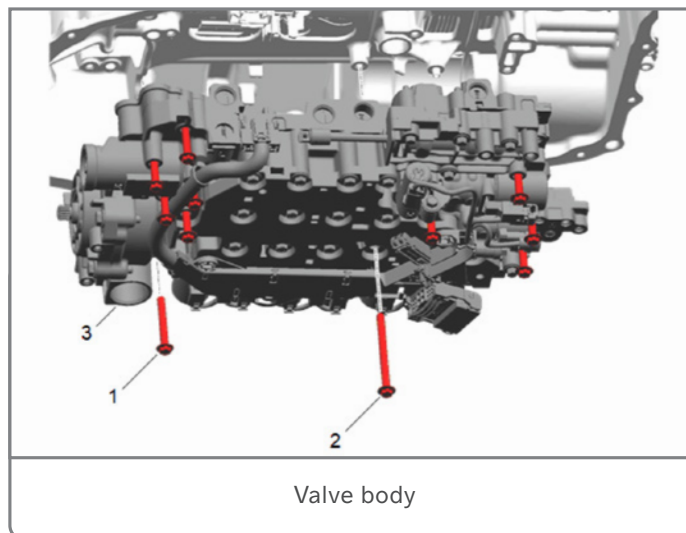
If there is excessive debris in the transmission pan, or the condition remains following the valve body replacement and after performing the adaptive learning procedures, remove the transmission and inspect and reset the clutch pack travel as necessary.

the transmission pan and inspect for any debris. If there is not an unreasonable amount of debris found, based on the mileage of the vehicle, replace the valve body. After installing the valve body, complete the procedures in Bulletin #16-NA-019.

Setting the clutch pack travel to the tighter end of the range tends to produce a more appealing shift. During tear down, the steels should be inspected for uneven or excessive wear and replaced as needed if there is damage or distress seen to the friction discs.
