Hands-Free Start Power Modes .....	2
Lunch with Your FSEs Meetings Now Offer Three Convenient Call Times .....	5
Headlamps Flashing Due to Low Battery Charge .....	6
Rear Axle Differential Lock Control Actuator Condition .....	7

## TECH LINK

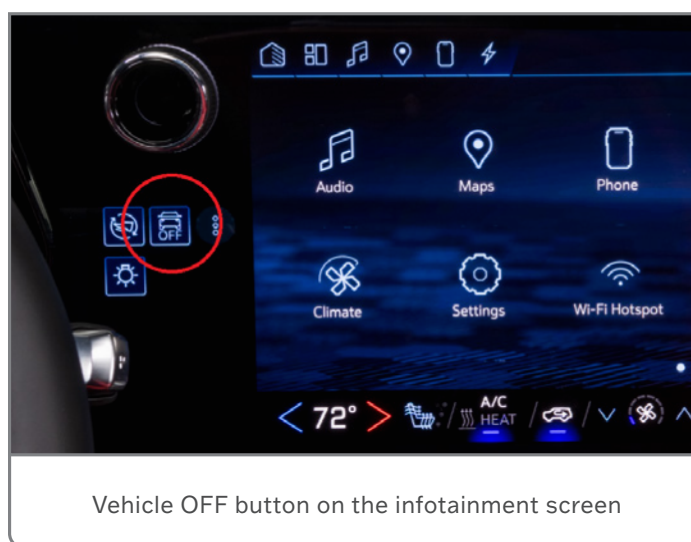
Vehicle OFF button on the infotainment screen

If the vehicle has not been shifted out of Park, it will not turn off based on driver-exit detection and will need to be turned off using the virtual OFF button on the infotainment screen or by waiting for the automatic power mode time out.

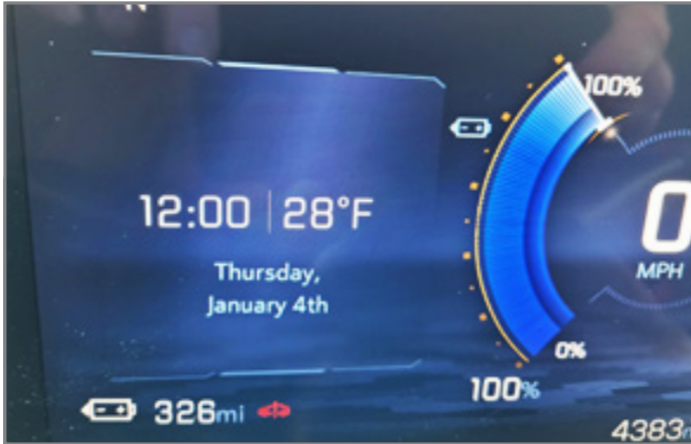
Service Mode is identified by the red icon on the instrument cluster.
