Diesel Exhaust Fluid Supply Pipe Contamination

Diesel Exhaust Fluid Supply Pipe Contamination.....	2
Transmission Whine Sound	4
Power Tonneau Cover Tips.....	6

TECH LINK

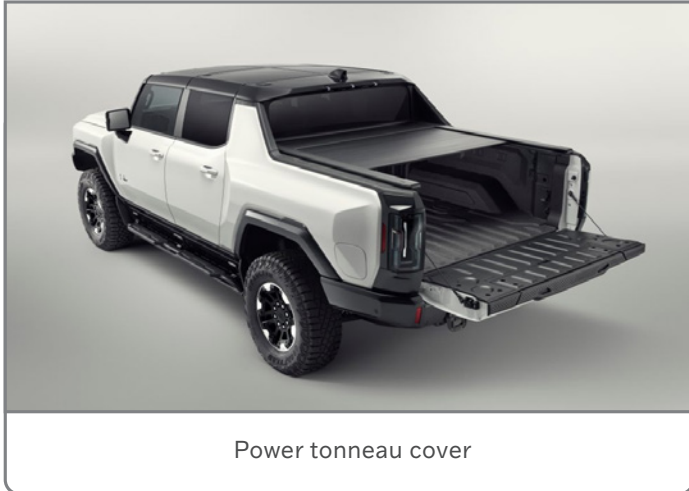
The GM Accessory Power Tonneau Cover (part number 86575628 or 86595165) is available on 2022-2024 HUMMER EV Pickups. If the hard power-retractable tonneau cover is not operating properly, check out Bulletin #24-NA-028, which has a number of diagnostic tips and adjustment procedures to help with repairs.

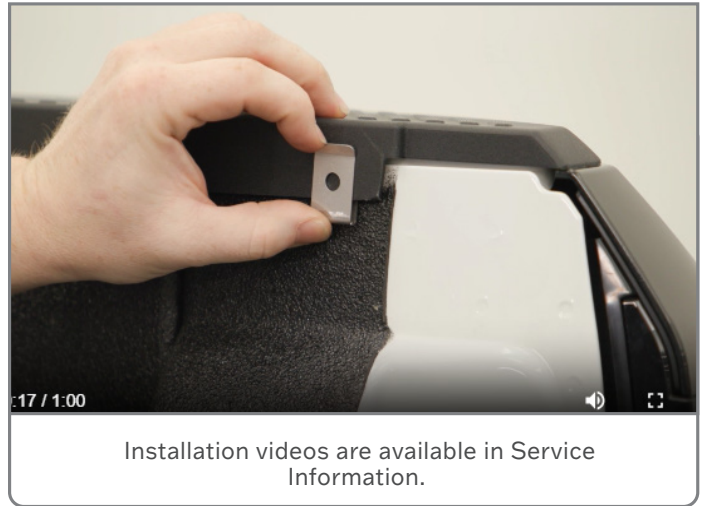
Installation of the seals also require careful attention. A folded seal may bind, causing the system to go into an unwanted anti-pinch mode during operation. Use tape to hold the top lip seal of

the side rail during installation of the side rail to the canister.

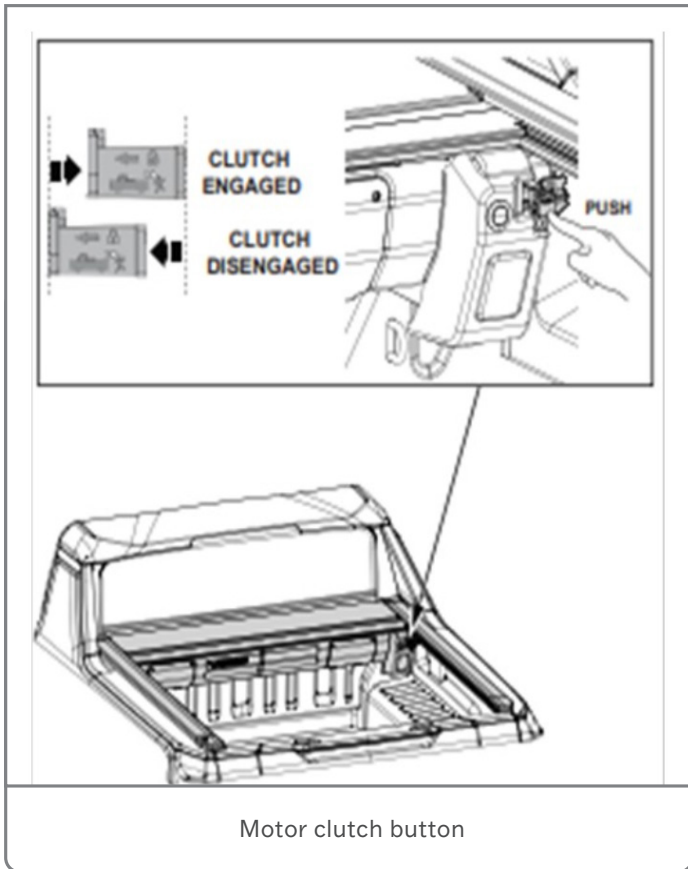
if the vehicle's 12V battery is disconnected for service. The cover also should be recalibrated if the motor clutch button has been disengaged.
