Window Indexing After Loss of Vehicle Power

Window Indexing After Loss of Vehicle Power.....	2
Inoperative Trunk Latch.....	3
PicoScope Recording for CVTs with Noise Concerns.....	6
Newly Arrived EVs May Not Charge.....	7

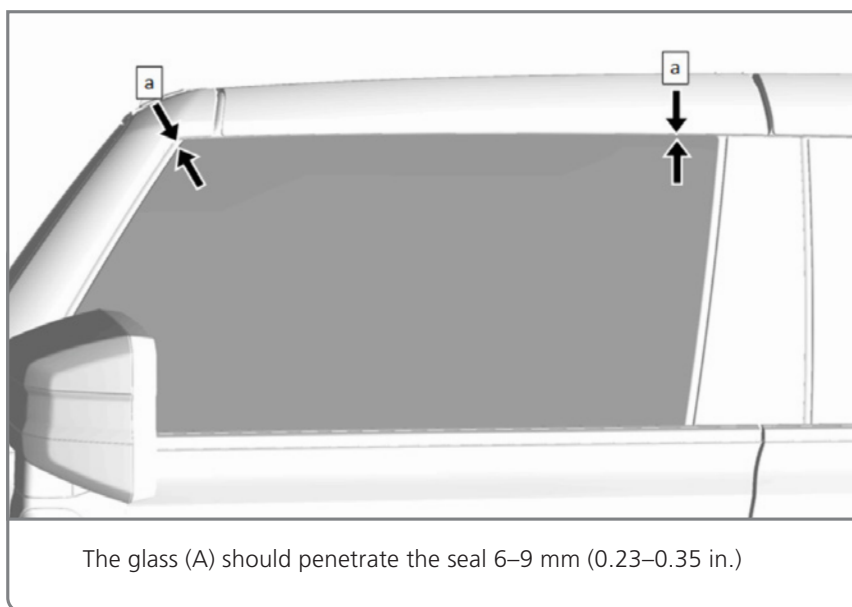
DTCs B1956 55, B1957 55, B1958 55 or B1959 55 (Side Door Window Regulator Motor) will set and an “Open, then Close the Driver Window” or “Open, then Close the Passenger Window” message will display on the Driver Information Center when the Body Control Module (BCM) has detected that the window

motor is not configured. In addition to 12V battery conditions, the DTCs may set if the door wiring harness or window motor has been disconnected. The DTCs will clear once the windows have been programmed, or normalized, and the indexing feature is restored.

Once the windows are indexing properly, check the front side door window glass-to-seal penetration. The glass should penetrate the seal 6–9 mm (0.23–0.35 in).

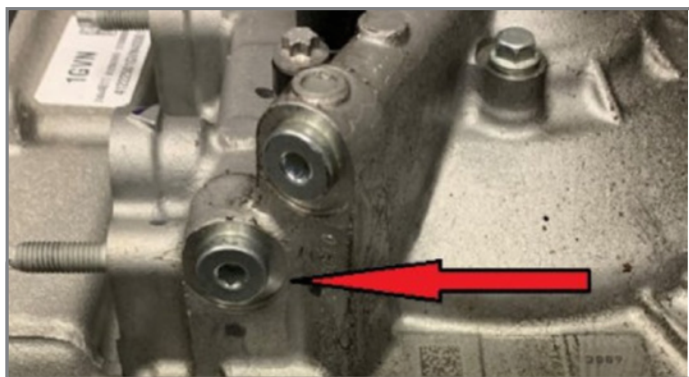
Place the PicoScope sensor on the plug located on the left side of the transmission.

To use the PicoScope to record any internal transmission noise, place the PicoScope sensor on the plug located on the left side of the transmission at the base of the unit. The plug is used as a pressure tap for the pulley assembly. Close the hood and run the sensor cable into the passenger compartment.
