Dual Clutch Transmission MCVM PUN Characterization

DCBS Warranty Requirement
Deadline Extended 2

6-Speed Automatic Transmission
Oil Filter and Seal Now
Available Individually 4

Crankshaft Bearing Diagnosis..... 5

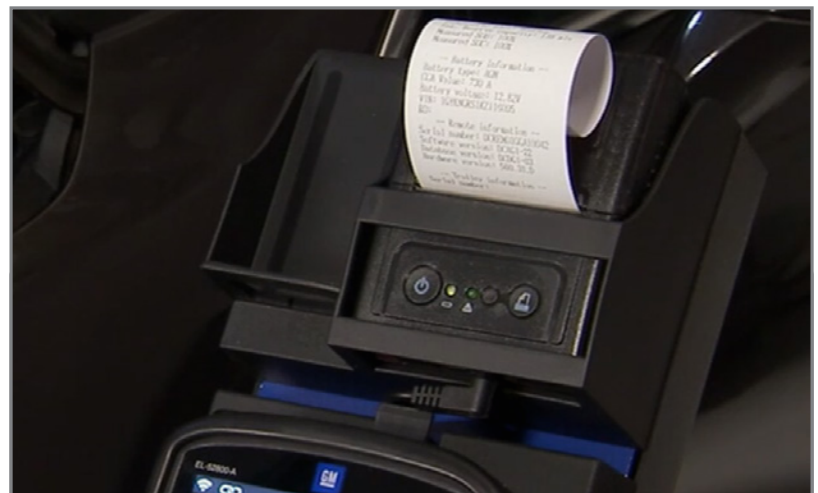
The DCBS Warranty Claim Code test result printout will be the only acceptable supporting documentation for warranty battery replacement transactions.

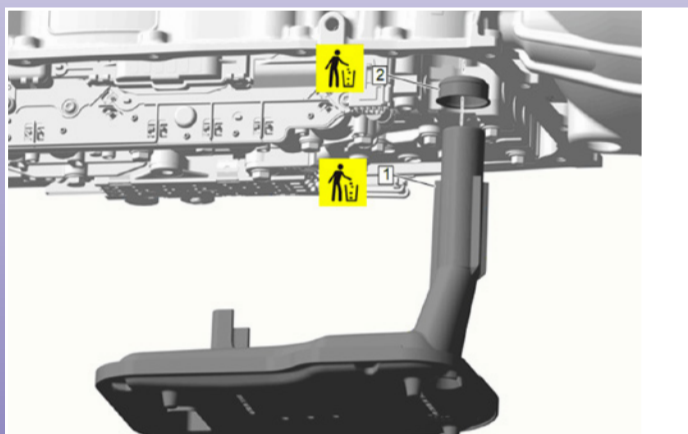
Filter (#1) and seal (#2)

The filter and seal currently included in the Transmission Oil Filter and Seal Kit will now be available individually. The parts being sold individually will help improve packaging efficiencies. To obtain the filter and seal, order filter part number 24236517 and

seal part number 24225347. The Electronic Parts Catalog (EPC) is being updated to reflect these changes.

Current service procedures require that the seal be replaced anytime the filter is removed. The fluid pan gasket is reusable. The gasket should be replaced if it is stuck to the case or pan. Be sure follow the appropriate Service Information procedures and use the correct special tools when installing the filter seal.
