Transmission Not Shifting, Defaults to 5th Gear 4

Preventing Rear Glass Damage During Folding Top Service 5

Loss of Forward Gear on CVT Transmission 6

TECH LINK

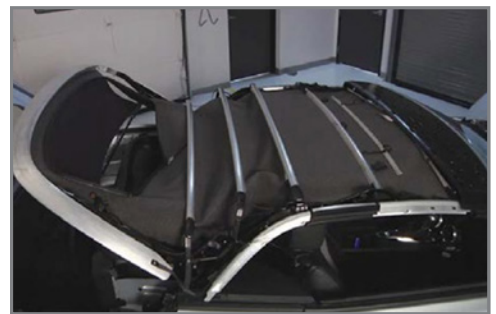
Folding top canvas replacement

For an inside look at Camaro folding top canvas replacement, check out the video included in the August 2018 Emerging Issues seminar, course number #10218.08V, on the Center of Learning.
