# Corvette E-Ray

Corvette E-Ray Delivers  
Electrified AWD Performance ..... 1

Use Correct Labor Code  
for Tire Valve Stem Repairs..... 4

Insufficient Dual Tank Fuel Transfer..... 5

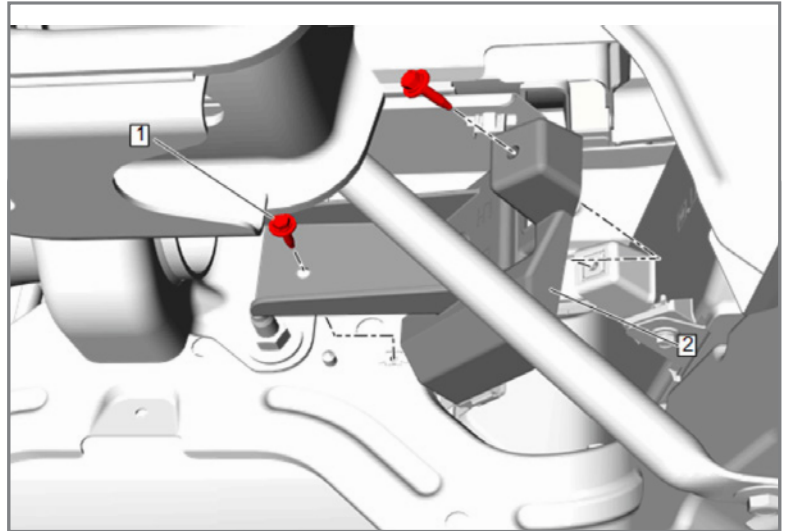
A Side Detection System Temporarily Unavailable message may be displayed on the instrument cluster of some 2024 Silverado 2500 HD/3500 HD and Sierra 2500HD/3500 HD trucks. There also may be false alerts or the system may operate erratically or not at all. These conditions may be caused by a decal attached to the radar-emitting side of one or both of the Side Obstacle Detection Modules

Any decals or stickers that are attached to the radar-emitting side of the Side Obstacle Detection Module can cause interference or blockage of the radar and must be removed. The Side Obstacle Detection Modules are attached to the rear bumper impact bar brackets. Once the decal is removed from the module and the vehicle is driven, the Side Obstacle Detection Modules will automatically learn the blockage has been removed and return to normal operation.

Side Obstacle Detection Module

Refer to #PIT6161B for more information.
