Mid-May 2024, Volume 26, No. 10

Noise from the Transmission Area

Wheel Drive Shaft Retention Snap Ring Design Change

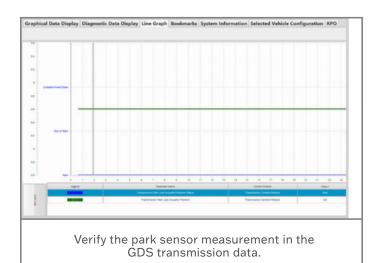
There may be a noise from the bell housing area of the DCT TR9080 transmission (RPO M1L, M1M) on some 2020-2024 Corvettes along with a number of DTCs set in the Transmission Control Module (TCM). The noise may be due to a dislodged snap ring in the direct clutch assembly. As a result, one or more pressure DTCs may set if there is debris caused by the valves sticking in the Main Control Valve (MCV) Body or the direct clutch may contact the fluid tubes, stator shaft or transmission housing.

If the noise from the bell housing area follows engine RPM and can be duplicated without moving the vehicle, verify that the vehicle has the latest TCM calibrations, set up a TAC case and attach the PicoScope sound files (refer to Bulletin #21-NA-049), and verify the park sensor measurement in the GDS transmission data for Park Lock Valve (PLV) drift (refer to Bulletin #23-NA-176).

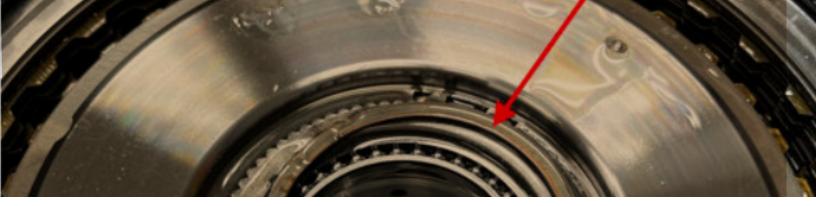
Inspect the direct clutch for failure by removing the MCV and check the clearance between the direct clutch and fluid tube using a feeler gauge. If the clearance is 0 mm with obvious contact, follow the repairs for Direct Clutch Replacement in the appropriate Service Information. If the clearance is 0.5 mm, follow the repairs for direct clutch pump gear noise.

While inspecting the pump gear for damage, if the direct clutch can be removed easily but there is contact with the pipe and stator, replace parts as needed. Light damage to the housing caused by direct clutch contact will not require replacement.

Possible areas of concern on the stator housing caused by direct clutch contact.

- If there is direct clutch snap ring failure without any DTCs set as current, replace the direct clutch and stator. In addition, remove the transmission pan to clean any debris from the magnets and replace the sump and canister filter elements.
- If there is direct clutch gear noise, replace the direct clutch, stator and pump gear. Also remove the transmission pan to clean debris from the magnets and replace the sump and canister filter elements.
- If there is direct clutch snap ring failure with an illuminated MIL and pressure DTCs set, replace the direct clutch and stator. Also remove the transmission pan to clean debris from the magnets, replace the sump and canister filter elements, and replace the Main Control Valve (MCV).
