# Front Bumper Bracket May Affect Active Grille Shutter Operation

# 8-Speed Transmission Noise Concerns

# Adjusting the Hood Bumpers and Latch to Remove Low Spots on Hood

## TECH LINK

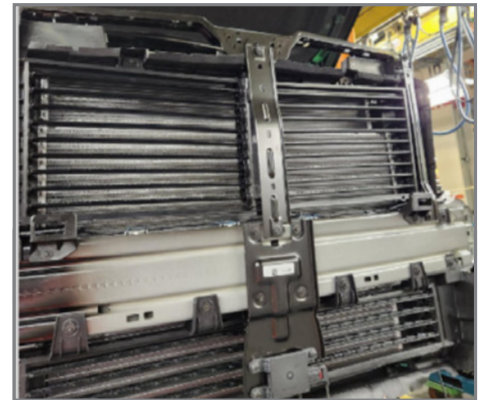
Some 2024 Acadia, Traverse; and 2025 Enclave models may have an active grille shutter malfunction along with DTC P059F (Active Grille Air Shutter 1 Performance) set in the Engine Control Module. These conditions may be caused by a bent hood-support front bumper bracket. The condition of the bracket should be inspected before replacing the active griller shutter.

Good front bumper bracket without any damage.

If the bracket is found to be bent, remove the bracket and command the active grille shutter using GDS2. If the shutter moves when commanded, replace the damaged bracket only. If the shutter does not move smoothly or does not operate properly, replace the bracket and the shutter. A good bracket is shown below. If there is not any damage found, follow the appropriate Service Information for the DTC.
