## Wiper Blade Performance Diagnosis

# Wiper Blade Performance Diagnosis

GM TechLink is published for all GM retail technicians and service consultants to provide timely information to help increase knowledge about GM products and improve the performance of the service department.

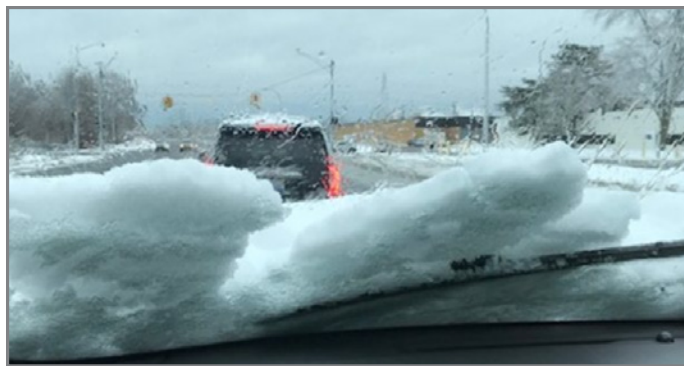
Ice in the wiper blade hinge should be cleared to allow the wiper blade to function properly.

Remove ice and snow prior to using the wipers.

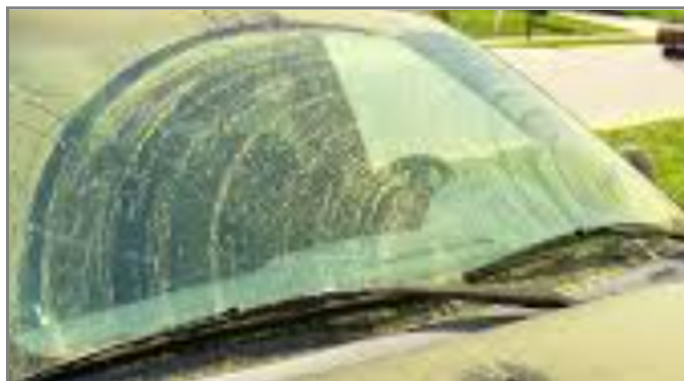
Clear the windshield before operating the wipers.

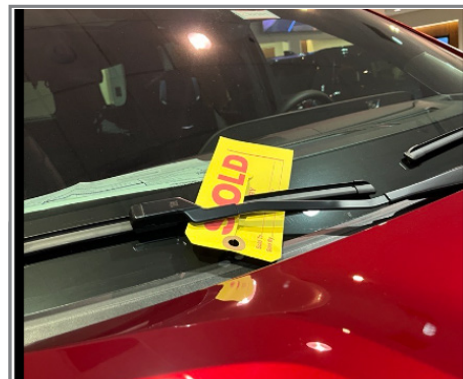
Do not place dealership paperwork under the wiper blade.

- Dealership service tickets or any paperwork should not be placed under the wiper blade. The rubber blade element should only be in contact with the glass as it can be distorted and possibly create a papercut on the blade lip.
- Stickers or decals should not be placed in the front or rear wiper areas as the sticker creates unnecessary wear each time it passes over the blade and compromises wiper quality.

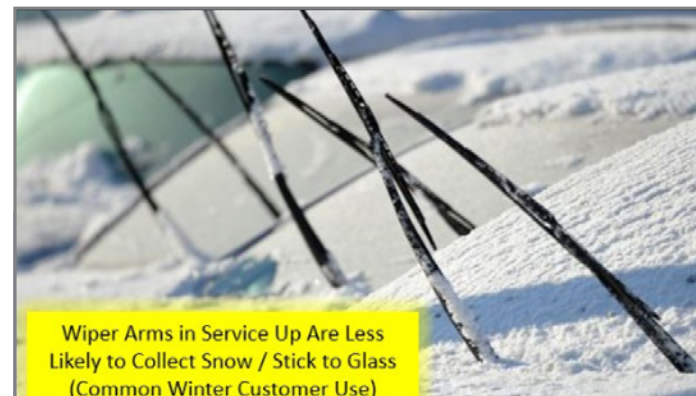
Wiper Arms in Service Up Are Less Likely to Collect Snow / Stick to Glass (Common Winter Customer Use)

Wiper arms in the “service up” position.

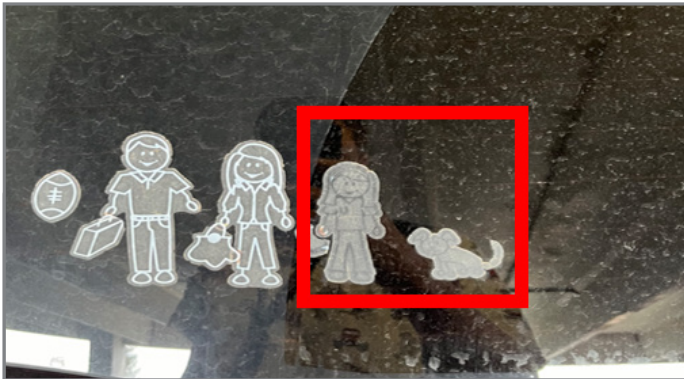
Decals should not be placed in the wiper areas.

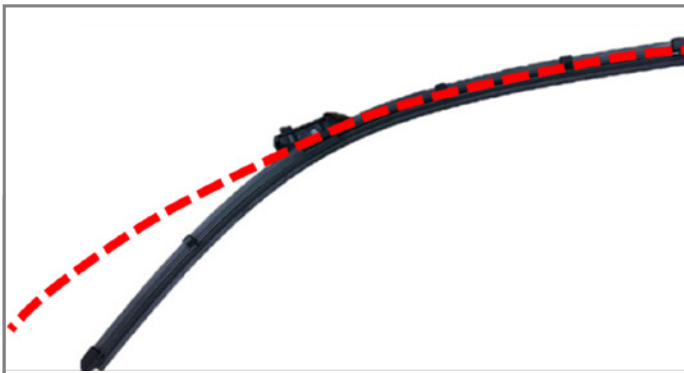
Ensure wiper blades are not straightened or bent.

- Precautions should be taken when handling the wiper blade to protect the blade element and avoid distortion. For example, blades should not be stacked on one another as the blade element can be distorted and take a “set” that compromises wiper quality. Wiper blades should be kept in the protective packaging as long as possible to mitigate outside damage.
- Special care should be taken to ensure wiper blades are not straightened or bent. OEM blades are designed to fit the contour of the glass. Once wiper blades are bent, the fit to the glass is compromised and can lead to wiper quality issues.

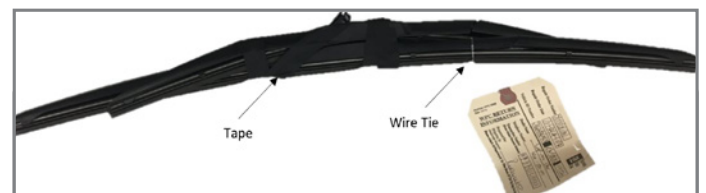
Properly package the part return when requested.

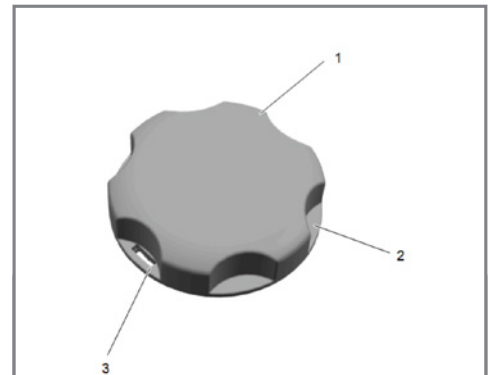
Rotate the surge tank cap upper cover (#1) counterclockwise to align the slot (#3) in the cap cover with the slot in the cap body (#2).

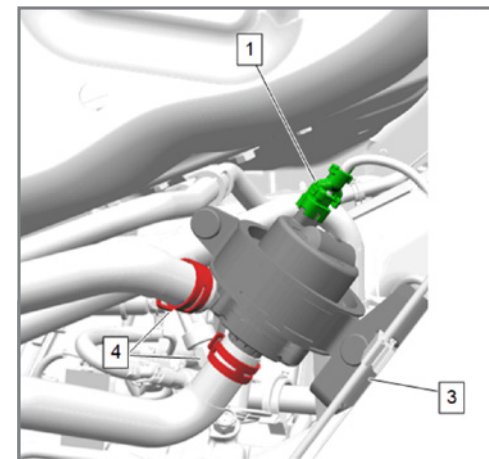
Run the pump to purge air from the system.

Use GDS 2 to run the Hybrid/Electric Vehicle Battery Coolant Pump at 4,000 RPM for 15 minutes. If the coolant level drops, fill the cooling system using DexCool 50/50 Premix.

The coolant level should just cover the white indicator at the bottom of the small coolant reservoir. For reference, the total system volume is 1.9 L. Run the pump again if needed to purge all air from system.

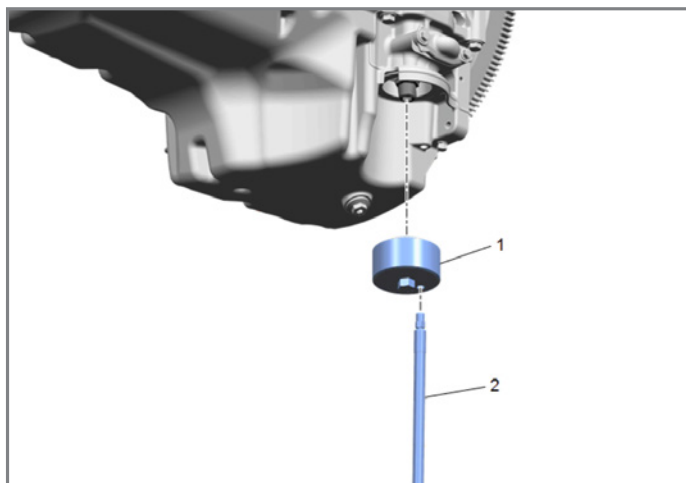
Oil filter pressure testing

Oil pressure can vary greatly at the oil filter location vs. at the oil pressure sensor location using the adapter specified in the service procedure. A difference of up to 10 psi may be found when checking oil pressure at both locations during testing
