Mid-October 2024, Volume 26, No. 20

## **Follow All Guidelines to Determine Hybrid/EV Battery** Stability, Return Shipping Requirements

## Follow All Guidelines to Determine Hybrid/EV Battery Stability, Return Shipping Requirements

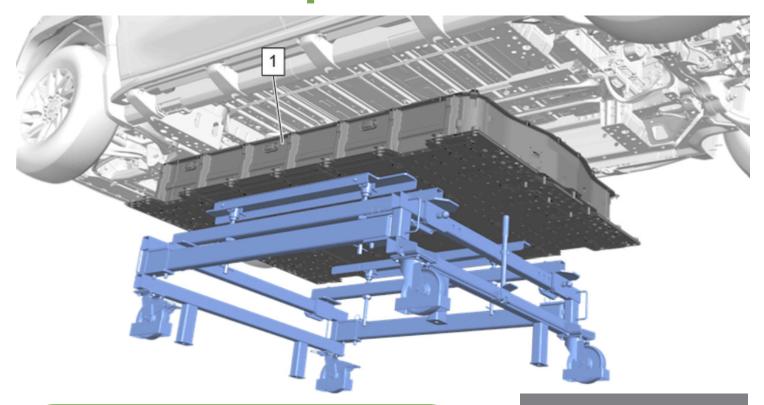
High-voltage battery

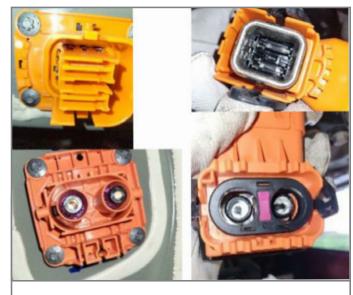
Battery pack HV connectors and headers

- Inspecting the coolant level.
- Checking the GDS2 session log for Hybrid/EV Vehicle Battery Pack Thermal Stability Data.
- Moving the vehicle to a stable location.
- Starting a TAC case.
- Disabling high voltage at the A4 Hybrid/EV Battery Pack.
- Inspecting all battery pack HV connectors and headers.
- Removing the HV battery pressure equalizer vent and inspection plug and checking for moisture and coolant.
- Performing the Hybrid Battery Pack Coolant Passage Leak Test.
