## Guidelines for Successful Installation of GM Accessories

Guidelines for Successful Installation of GM Accessories.....	2
MDI 2 Order Lead Times Update .....	5
DTCs Set Due to Wiring Harness Condition.....	6
Low Oil Pressure at Idle .....	7
Heavy Fuel Use Message .....	8

## TECH LINK

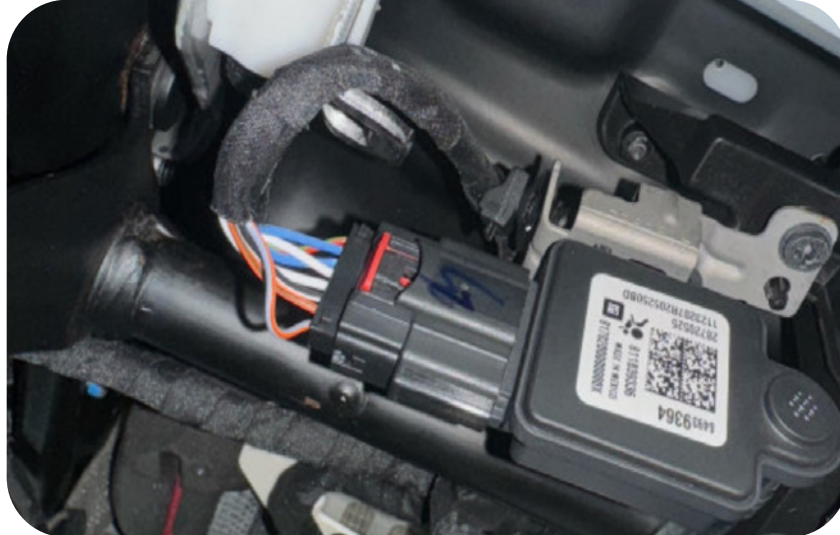
There may be several communication DTCs set along with several Driver Information Center messages — Service Power Steering, Service StabiliTrak, Service Rear Drive, Service Restraint System — displayed on some 2020-2024 CT5 and CT5-V models.

Check if one or more of the following DTCs are set: U0075 (Control Module Communication CAN Bus 1 Off), U0131 (Lost Communication with Power Steering Module), U0151 (Lost Communication with Restraints Control Module), U0420 (Invalid Data Received from Power Steering Module), U0452 (Invalid Data Received from Restraints Control Module), B197D (No Environment Identifier Received from Restraints Control Module).

If there is damage to the wiring harness, repair the harness following the wiring repair procedures in the appropriate Service Information.

After repairs are completed, reroute the wiring harness to prevent any contact with the seat frame.
