# Keep Your Cool — Air Conditioning Refrigerant Leak Diagnostic Tips

# Unlatching the Front Compartment Hood with a Weak 12V Battery

# Super Cruise Disengages or is Unavailable

# Water Leak at the A-Pillar Body Plug

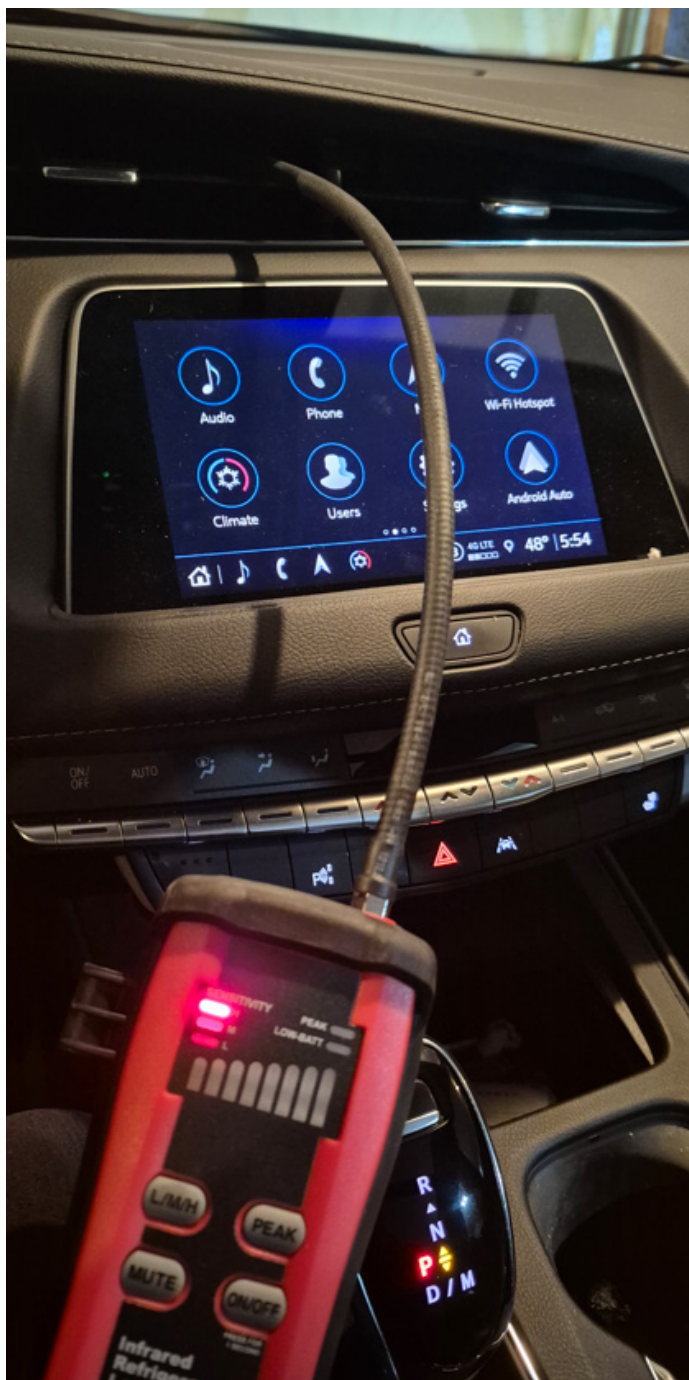
All current GM vehicles are manufactured with fluorescent dye installed in the air conditioning refrigerant system. The dye mixes and flows with the A/C compressor oil to help in locating any leaks in the A/C system over time. Leaks in the system will be indicated in a light green or yellow color when using the GE-42220 Universal 12V Leak Detection Lamp to check fittings and connections, A/C components, seals, hoses and other areas.

Fluorescent dye will assist in locating most medium-to-large leaks in the A/C system, but to verify some passive leaks, the GE-50078 Electronic Leak Detector or other SAE J2913-certified electronic leak detector may be required.
