New Rear Heating/Cooling System Provides 3rd-Row Comfort

TECH LINK

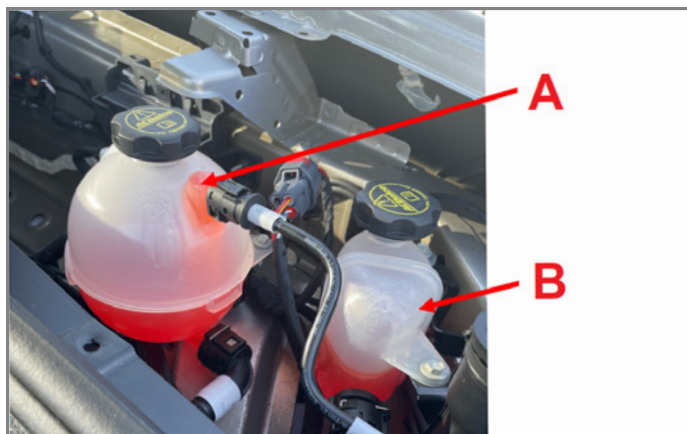
Since the two cooling systems are isolated from each other, if the 3rd-row auxiliary coolant bottle is low, any potential leak cannot be associated with the high-voltage propulsion system.

RESS coolant reservoir (A) and 3rd-row HVAC system reservoir (B) (ESCALADE IQ shown).

To purge the system, perform the Rear Passenger Compartment Coolant System Fill Request using GDS2. Listen for water pump activation and movement of the control valves while monitoring the coolant level in the surge tank. Add coolant as necessary to maintain the fluid level at the cold fill line.

After the process is completed, fill the surge tank to the cold fill line and wait two minutes. Next, disconnect the negative battery cable, wait three minutes and reconnect the cable.

Repeat these steps to ensure the cooling system has been adequately filled and then use GDS2 to perform the Rear Passenger Compartment Coolant System Test. The test will check that the system is operating properly.

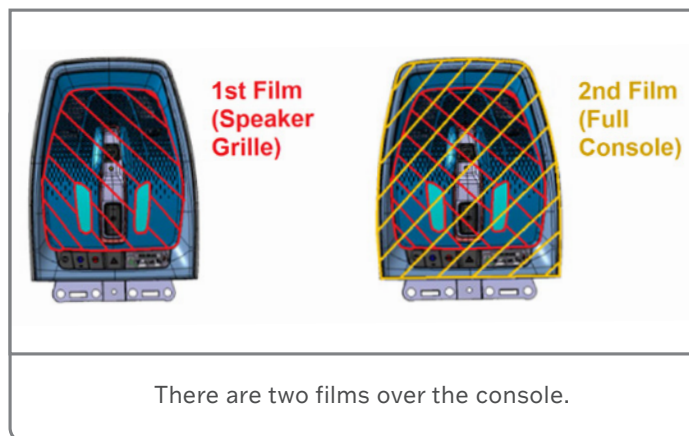
In some cases, the smaller clear protective film covering the speaker grille may be missed during PDI, leading to an unnecessary return visit by owners to the dealership for service.

If left in place after vehicle delivery, either of the protective films may trigger a false interior motion reading by the intrusion sensor of the Content Theft Deterrent System mounted in the overhead console.

TIP: Both protective films should be removed during PDI. Removing the films after vehicle delivery is not a valid warranty claim. Refer to the ESCALADE IQ Pre-Delivery Inspection Form for all inspection items.

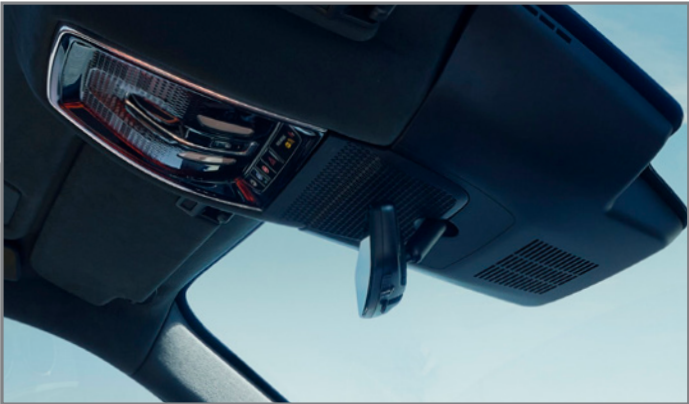
Overhead console with both protective films removed.

If there is a false theft alarm condition on the vehicle, check that both protective films have been removed from the overhead console before making any repairs.

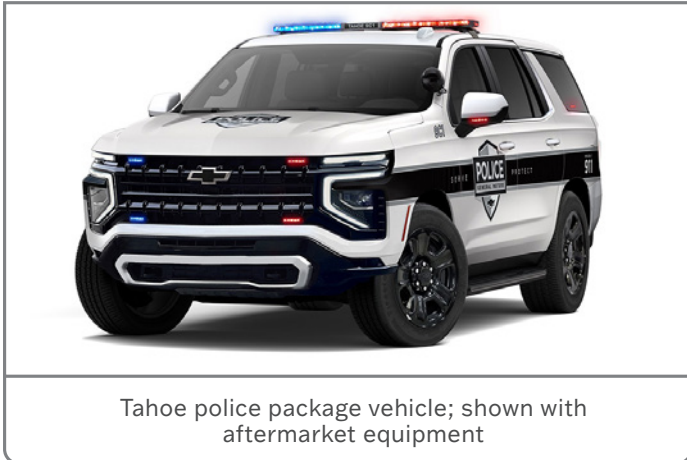
Tahoe police package vehicle; shown with aftermarket equipment

On these vehicles, it may be difficult to learn additional Remote Keyless Entry transmitters (key fobs) to the vehicle during the immobilizer learn procedure. To address this condition, updated Body Control Module (BCM) calibrations have been released to assist with the immobilizer learn process. Be sure to update the BCM with the latest calibrations before learning new key fobs.
