## New Diagnostic Strategy: Reprogram Control Modules Before Replacement

# New Diagnostic Strategy: Reprogram Control Modules Before Replacement

# New Dash Cover Addresses Windshield Glare

# Corvette Center Console Latch Pushbutton Replacement

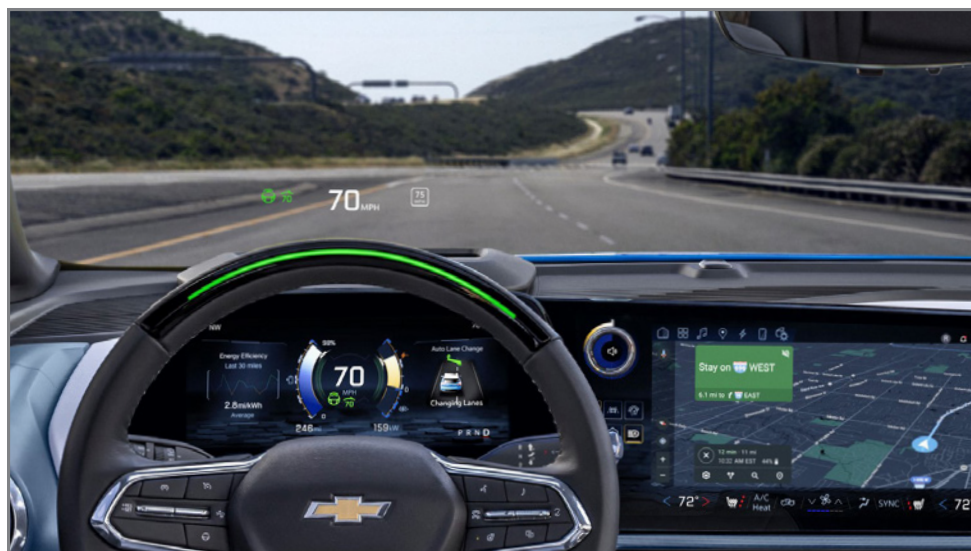
While driving into direct sunlight or under street lights at night, some drivers of 2024-2025 Equinox EV models may notice glare from the dash reflected onto the windshield. The dash valance panel has unique feature lines that may reflect on the windshield due to their reflective angles.

Glare may be seen reflecting on the windshield under some conditions.

In some cases, the glare may be distracting to the driver and passengers. Any customer concerns about the glare can be addressed with a new dash cover now available that can be installed over the top of the instrument panel.

It's recommended to stretch the cover over the valance panel by starting at the middle of the cover and working toward the A-pillars. Use a silicone or rubber seam roller to smooth out the cover after installation by hand is completed. It is normal to see some slight bumps where the adhesive pads/Velcro fasteners are located underneath the cover.
