## New 12V Battery Ratings Chart

### for the 2026 Model Year

GM TechLink is published for all GM retail technicians and service consultants to provide timely information to help increase knowledge about GM products and improve the performance of the service department.

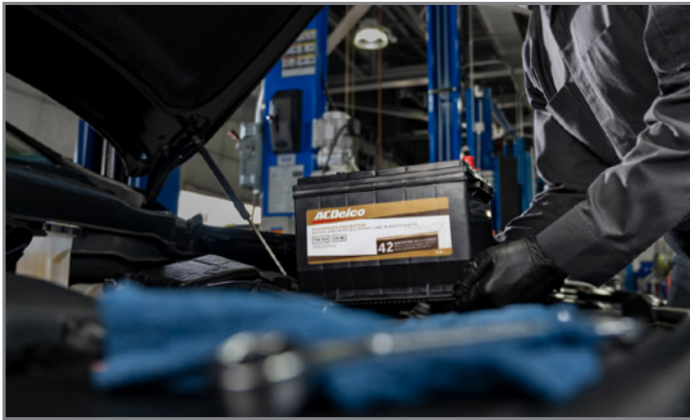
The latest Original Equipment (OE) Battery Ratings chart for the 2026 model year is now available under the Reference Charts menu for use when testing OE batteries.

The chart includes SAE cold cranking amperage (CCA), amp hours (AH) and reserve capacity (RC) ratings along with battery type specifications. The 2026 model year chart as well as charts for earlier model years can be easily printed using the browser's print function.

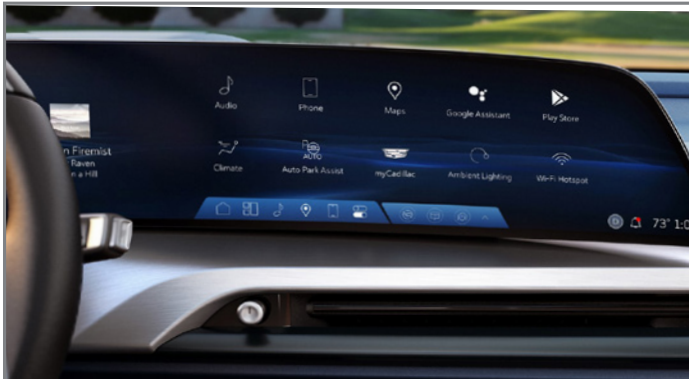
Select the myCadillac app on the infotainment screen to download the digital Owner's Manual (VISTIQ shown).

To download the digital manual, go to myCadillac on the infotainment screen and select the gear icon. From the Owner's Manual screen, select Install Now.
