# HUMMER EV Sky Panel Adjustment Tips

## TECH LINK

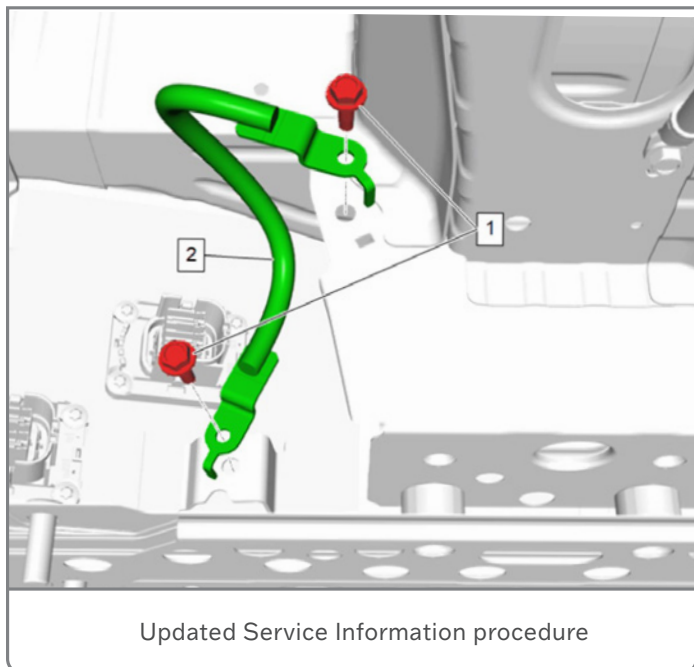
New high-voltage battery packs for 2022-2026 HUMMER EVs, BrightDrop EVs; 2024-2026 Silverado EV, Sierra EV; and 2025-2026 ESCALADE IQ models are now shipped to the dealership without the rear ground strap and/or the rear ground strap mounting bracket, which have been eliminated in production.

The removal of the rear ground strap bracket has required an update to the high-voltage battery pack installation procedure in Service Information.

If there is a rear ground strap bracket on the new high-voltage battery pack, bolt the strap back on to the battery pack during installation.
