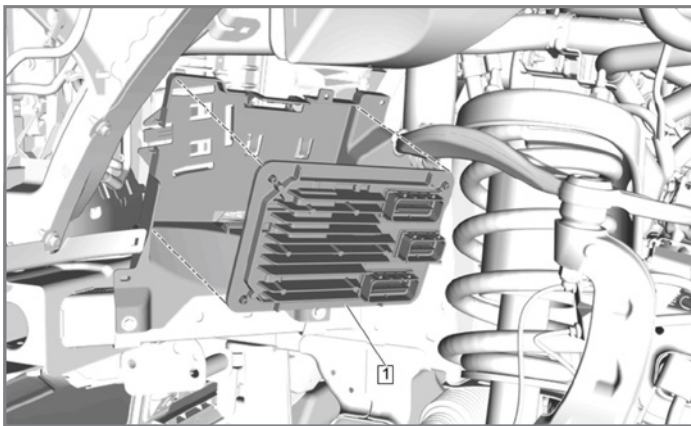
ECM (Sierra shown)

The E01 Engine Control Module (ECM) for 2022-2026 CT4, CT5, Silverado, Sierra; 2023-2025 Envision; 2023-2026 Colorado, Canyon; and 2024-2025 XT4 models equipped with the 2.0L engine (RPO LSY) or 2.7L engine (RPO L3B) has been placed on a part restriction. The restriction will help gather product feedback before replacing the ECM. :

As part of diagnostic process, verify the vehicle condition is not related to a wiring/connection issue or calibration update. Review the following bulletins for more information:

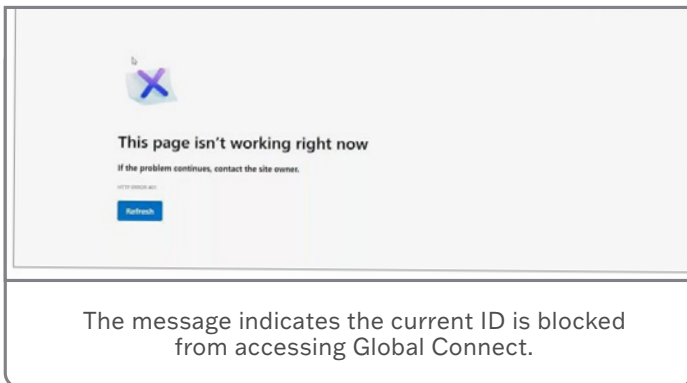
The following message may be seen when attempting to access Techline Connect:

The message indicates that the current ID is blocked from accessing Global Connect. This can be for several reasons but typically is due to a counterfeit MDI device.

To unblock the account, reach out to TCSC via CX Connect with the following information:

- User ID in Global Connect
- Email of User

TCSC will be able to reach out to the Cybersecurity team that will be able to determine the cause of the block and may be able to unblock the account. In the case of a counterfeit MDI, the counterfeit tool must be destroyed, and a legitimate Bosch device must be used to ensure the ID is not blocked again. Repeat offenders may not be unblocked from access.
