## Heated Steering Wheel Replacement

# Heated Steering Wheel Replacement

# Stay Updated — IOK Radio Software and Connection Conditions

# Verify Vehicle Settings After Rocker Panel Ground Lamps Installation

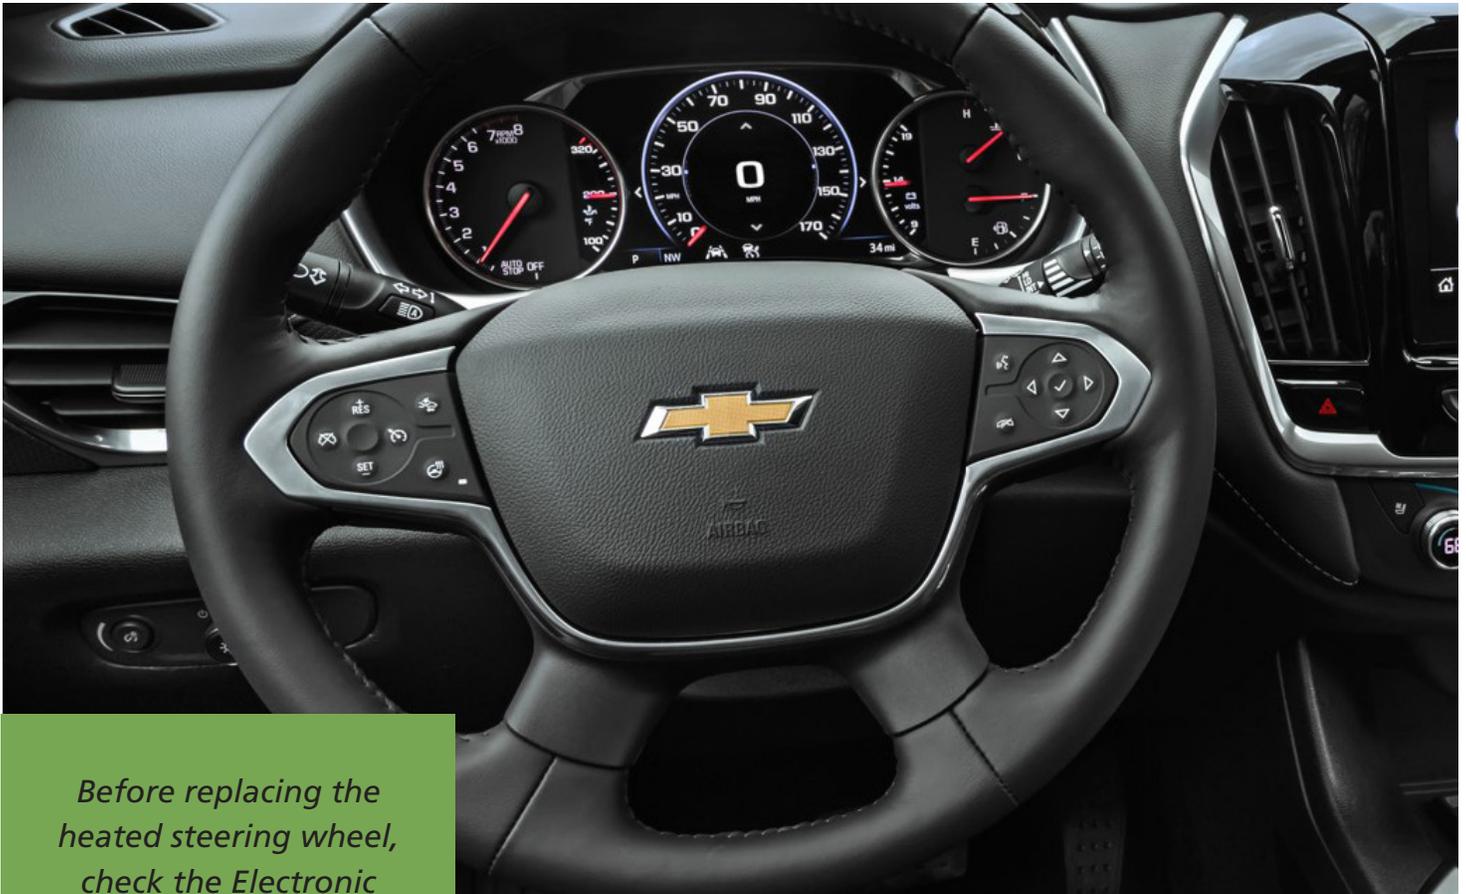
*Before replacing the heated steering wheel, check the Electronic Parts Catalog to ensure the correct steering wheel for the vehicle application has been ordered for 2022 model year vehicles equipped with Global A or Vehicle Intelligence Platform (VIP), or Global B, technology.*

If the incorrect steering wheel is installed, the cruise control switch and heated steering wheel switch will be inoperative.

Check that the correct steering wheel for the vehicle application has been ordered.

Steering wheel bolts installed during manufacturing require high torque efforts to remove. The only acceptable bit for removing and installing the steering wheel bolt is a T50 Torx bit. Do not use any other size bit or a worn bit.

Once the steering wheel is removed, be sure to transfer components as necessary. Refer to Steering Wheel Replacement in the appropriate Service Information for more information.

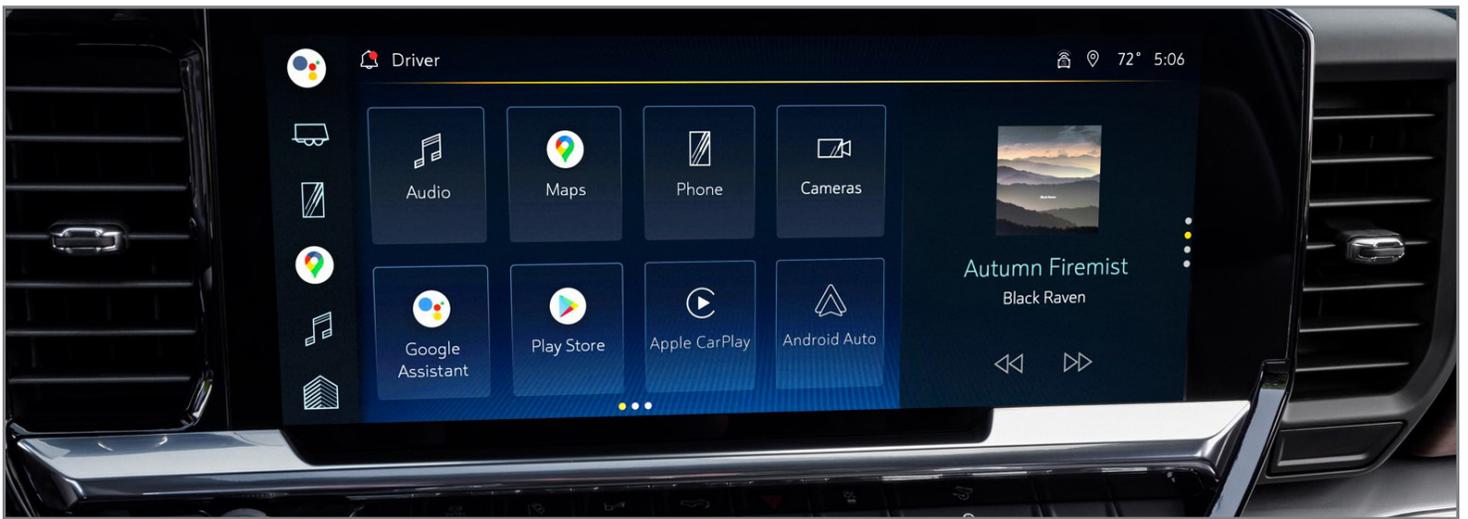
There may be several audio system conditions on some 2022-2024 Tahoe, Suburban, Yukon; 2022-2025 HUMMER EV; 2022-2026 Silverado 1500, Sierra 1500; 2023 BrightDrop; 2024-2025 Corvette; 2024-2026 Silverado 2500HD/3500HD and Sierra 2500HD/3500HD models equipped with the IOK radio. The audio system conditions may include no audible sound, a blank or frozen display screen, a Return to Dealer or Demo Mode message, or a phone connection concern. These issues are covered in the latest version of #PIC6602.

There are a number of steps to follow to determine if these conditions are related to a software, connection or hardware issue, which may include resetting the radio, verifying system software is up to date, checking that the customer's phone software is up to date, or performing a data wipe to restore functionality. Additional information can be found in #PIC6002P as well as several other PI's covering the following issues:

Be sure to follow all steps to ensure repairs are completed properly.

Do not replace the radio for any of these issues. These radios are currently restricted through the Electronic Service Center. Ensure that the module has been reset, the latest software installed and that the radio has been disconnected and reconnected.
