# Front Brake Caliper Sound and Uneven Pad Wear

*There may be a front caliper brake noise or uneven front brake pad wear on some 2023-2026 Colorado and Canyon trucks*

GM TechLink is published for all GM retail technicians and service consultants to provide timely information to help increase knowledge about GM products and improve the performance of the service department.

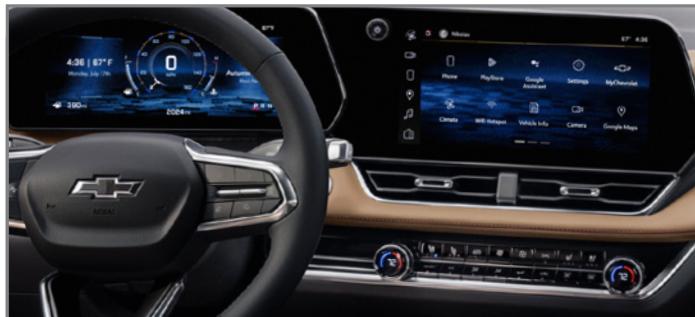
A blank or black screen display affecting the instrument cluster, infotainment screen, or both, on some 2022-2026 Silverado, Tahoe, Suburban, HUMMER EV, Sierra, Yukon; 2024-2025 XT4; 2024-2026 Encore GX, Envision, Envista, LYRIQ, Blazer EV, Colorado, Equinox, Equinox EV, Silverado HD, Silverado EV, Sierra HD, Sierra EV, Trailblazer, Traverse, Trax, Acadia, Canyon; 2025 CT5; 2025-2026 Enclave, CELESTIQ, Escalade, ESCALADE IQ, OPTIQ, Terrain; and 2026 VISTIQ models may be due to several possible issues, including software as well as hardware concerns. These infotainment and instrument cluster displays include the RPO IVA, IVD, IVE and IOK systems.

Display screen issues may be due to software or hardware concerns.

Refer to #PIC6629 for complete instructions.

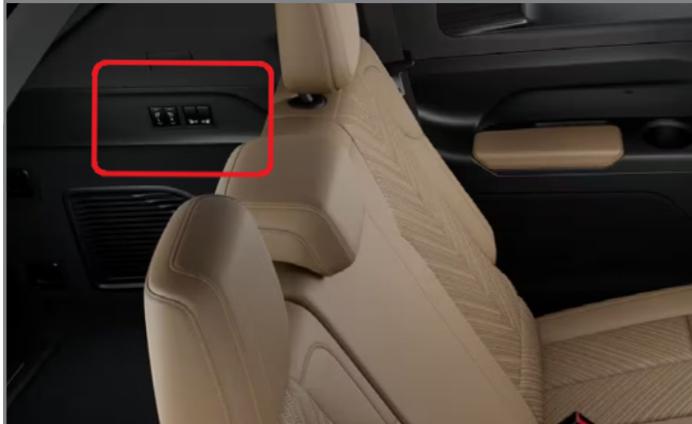
Some 2025-2026 ESCALADE IQ models may have a 3rd-row seat that cannot be operated using the 3rd-row seat switches in the cargo area.

If diagnosis indicates the switch is inoperative, take the switch apart and inspect for signs of corrosion. The cause of the inoperative switch may be water leaking into the switch from the roof ditch molding area. A corroded switch will need to be replaced.
