Front Brake Caliper Sound and Uneven Pad Wear

There may be a front caliper brake noise or uneven front brake pad wear on some 2023-2026 Colorado and Canyon trucks

GM TechLink is published for all GM retail technicians and service consultants to provide timely information to help increase knowledge about GM products and improve the performance of the service department.

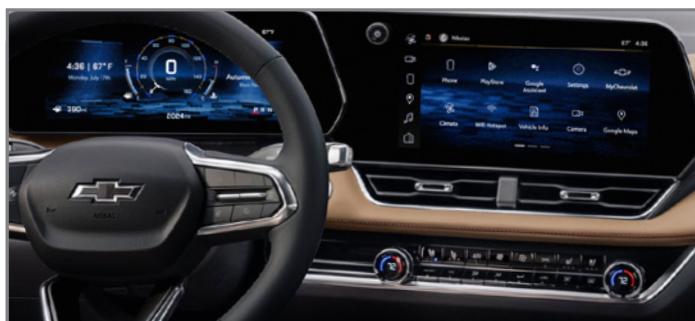
A blank or black screen display affecting the instrument cluster, infotainment screen, or both, on some 2022-2026 Silverado, Tahoe, Suburban, HUMMER EV, Sierra, Yukon; 2024-2025 XT4; 2024-2026 Encore GX, Envision, Envista, LYRIQ, Blazer EV, Colorado, Equinox, Equinox EV, Silverado HD, Silverado EV, Sierra HD, Sierra EV, Trailblazer, Traverse, Trax, Acadia, Canyon; 2025 CT5; 2025-2026 Enclave, CELESTIQ, Escalade, ESCALADE IQ, OPTIQ, Terrain; and 2026 VISTIQ models may be due to several possible issues, including software as well as hardware concerns. These infotainment and instrument cluster displays include the RPO IVA, IVD, IVE and IOK systems.

Display screen issues may be due to software or hardware concerns.

The latest version of #PIC6629 recommends a number of diagnostic tips and provides references to additional PI resources for the following issues:

Refer to #PIC6629 for complete instructions.
