NACS and CCS1 Charging Adapter Options

**Loss of Reverse/
Forward Grid Lines
in Camera View**

TCSC Top Issues This Week..... 7

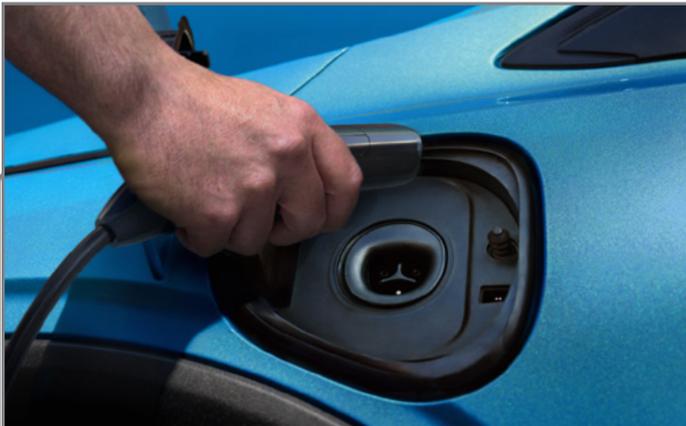
Bolt NACS charging port

The NACS charging standard combines both alternating current (AC) and direct current (DC) on one set of terminals. The J1772/CCS1 charging standard employs separate terminals for both AC and DC charging. Checking the terminals is a quick visual method to determine the purpose of any given adapter. Attempting to use an adapter improperly may set several DTCs in the vehicle.

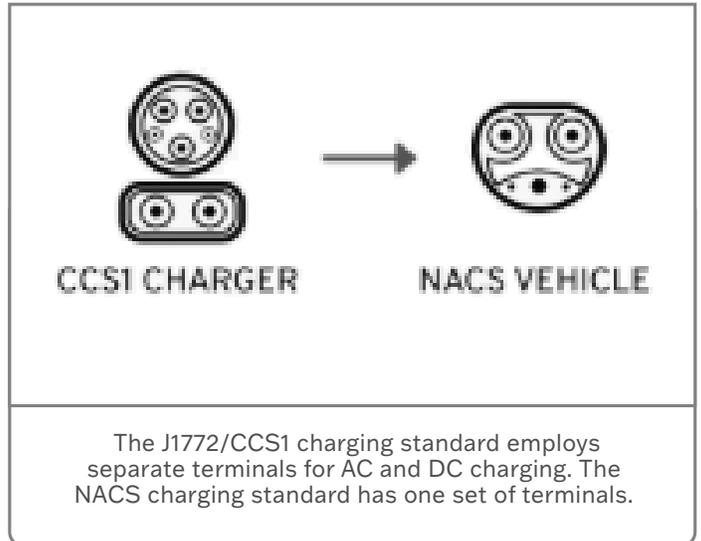
The J1772/CCS1 charging standard employs separate terminals for AC and DC charging. The NACS charging standard has one set of terminals.

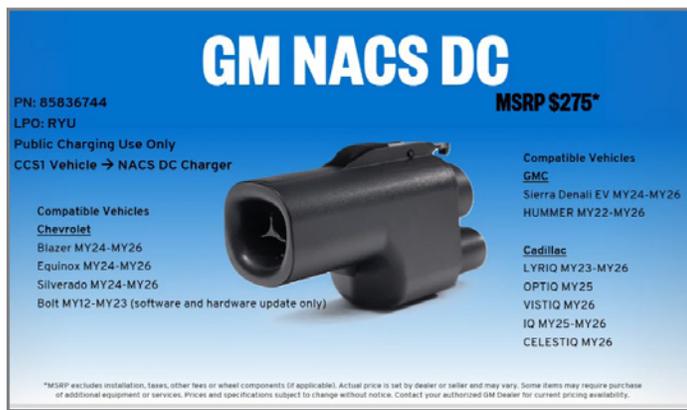
GM NACS DC ADAPTER

- CCS1 vehicle to NACS DC charger
- For public charging at specified Tesla Superchargers
- Not for use with NACS Level 1/Level 2 AC “home” chargers. DTCs P1EE6, or P0D3F, P2E85 and P0F71 (P0D3D-11, POE8B-11 and P0F70-11) may set if connected in this manner.
