CCND Labor Codes Updated for Infotainment Audio and Screen Conditions

Radiator Inlet Hose Coolant Leak

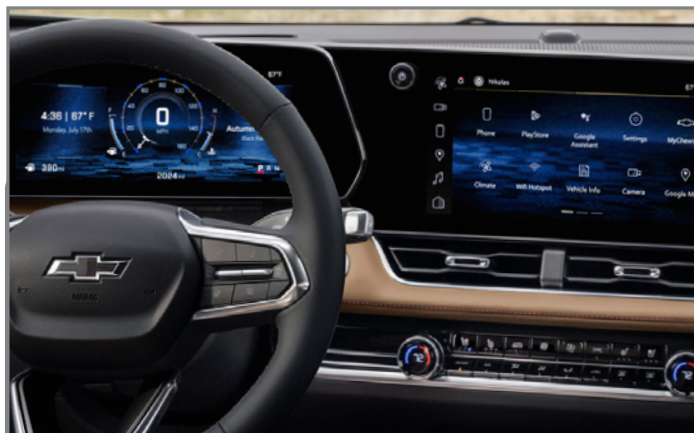
Equinox with VCU system

TIP: Be sure to use the correct system-specific labor codes when addressing concerns with instrument cluster screen performance or improper display operation. Driver Information Display or Virtual Cockpit Unit (VCU) labor codes only can be used for the applicable systems and are restricted by program.

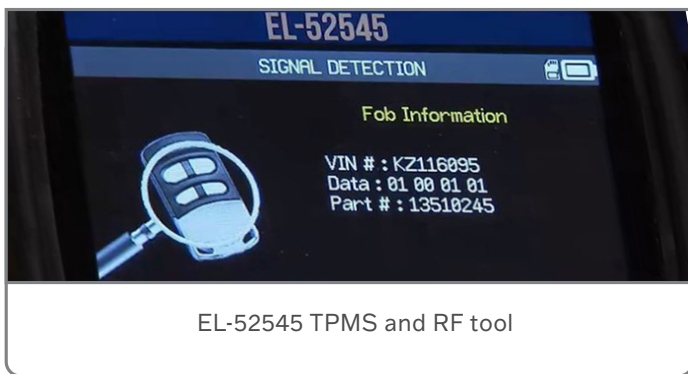
EL-52545 TPMS and RF tool

However, when the BCM counter becomes higher than the key fob counter, the out-of-synchronization condition may occur. The synchronization issue is usually the result of corruption within the memory of the BCM.

To correct this issue, repeatedly pressing any button on the affected key fob until the counter in the key fob matches that of the BCM will synchronize the two devices. This may take up to 255 button presses until the counters become synchronized again.

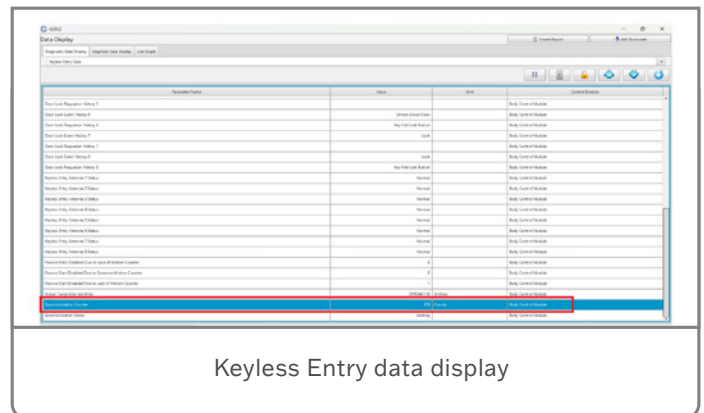
Keyless Entry data display

Entry Data list and view the Synchronization Counter parameter. Pressing any fob button should increase the Synchronization Counter parameter by one count for each button press. Keep in mind that Active Transmission Identifier and Synchronization Status may behave differently depending on vehicle program and software.

After verifying the fob battery is good, using GDS 2, go to Module Diagnostics > Body Control Module > Data Display > Keyless
