Engine Oil Consumption Guidelines

High Resistance in Glass Breakage Loop

Camshaft Position Sensor Performance Diagnosis

TECH LINK

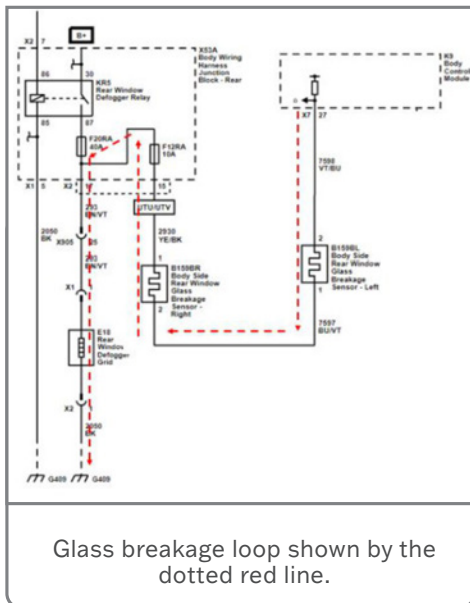
GLASS BREAKAGE LOOP

The glass breakage sensors are supplied a reference voltage of approximately 8 volts. The Body Control Module (BCM) monitors the glass breakage sensor signal circuit. If the rear side glass or back glass is broken, the glass breakage sensor signal circuit will open and the BCM will enter the alarm mode.

A low battery or battery disconnect can cause DTC B192A (Glass Breakage Sensor 2 Signal) to set current in the BCM. To clear the DTC, the BCM must run and pass its diagnostic when the theft deterrent system is armed.

If the resistance to ground is less than 20 ohms, the loop resistance is within specification and there may be an intermittent issue. Inspect and manipulate the glass breakage loop connections and wiring to see if the resistance increases. Repair any points of high resistance.

In some cases, it has been found that connection issues at the rear quarter glasses were caused by the installation of aftermarket window tint, decals, stickers, etc. These types of failures are not covered under warranty.

To arm the theft deterrent system, exit the vehicle with all the remote key fobs and close all the doors, liftgate and hood. Next, lock the vehicle with the key fob and allow several minutes for the theft deterrent system to arm. The system is not armed if the doors are locked manually. During this time,

the BCM will test the glass breakage loop. If the loop is complete, the DTC will go to history and no further repairs are needed.

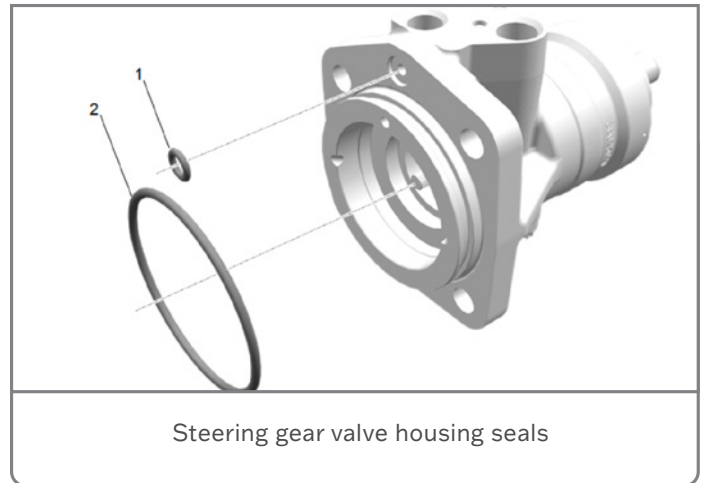
LEAK VS. SEEPAGE

Refer to Bulletin #15-00-89-004 for help identifying the differences between what is considered a fluid leak and what is considered seepage. Seepage is defined as oil, film, or dust accumulation on the exterior of the component. When fluid droplets appear hanging from a component or fluid has dripped to another component, it is considered a leak. Improper diagnosis may lead to unnecessary component replacement.

If the steering gear needs to be replaced, mark the location of the leak and identify the type of leak and location in the verbatim section of the repair order.

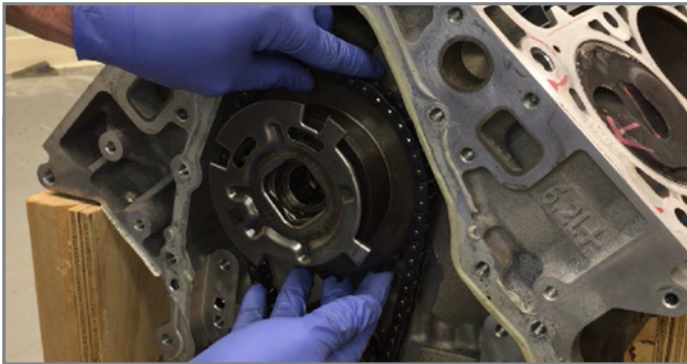
CMP actuator

The CMP contains a hall-effect sensor and additional electronics that processes the signal. It detects the change of strength of the magnetic field caused by the reluctor ring. There are 4 teeth on the edge of the camshaft position reluctor ring mounted on the camshaft. When the strength changes, the sensor changes the amount of current it consumes. This results in a square wave signal of current and voltage. The control module detects the frequency in which the signal changes, which is proportional to the rotational speed.

To help with diagnosis, the PicoScope can be used to evaluate the CMP sensors. The GM Technical Assistance Center (TAC) has seen an increase in sensor, circuit and ECM replacement due to DTCs P0340/341 and P0011/0016 without checking a scope pattern of the actuator interrupter ring. Comparing the wave form of a possibly damaged actuator ring with a known good wave form can speed up diagnosis due to the time and labor involved with engine disassembly as well as reduce unnecessary parts replacement.
