2nd-Row Rear Seat Operation and Diagnostic Tips for Full-Size SUVs

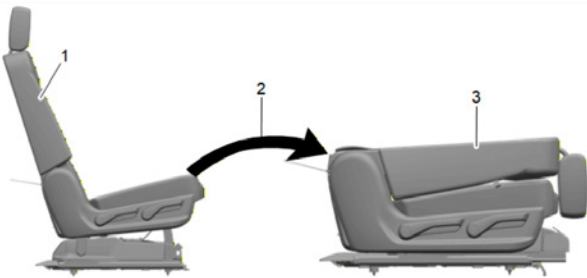
Fold-flat seat

If the 2nd-row seat will not release or fold down, or multiple attempts are required to get the seat to release, the actuator

cable may be disconnected or there may be interference with the quarter lower rear trim panel.

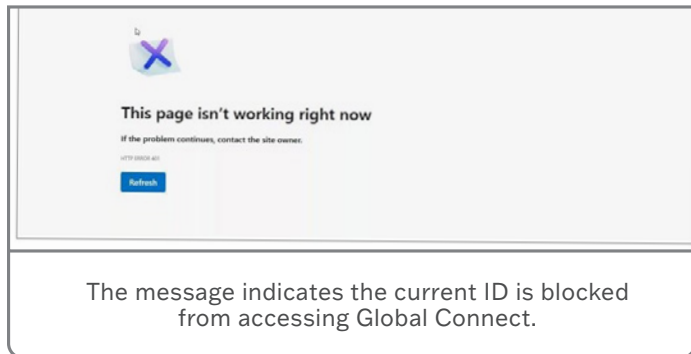
The following message may be seen when attempting to access Techline Connect:

The message indicates that the current ID is blocked from accessing Global Connect. This can be for several reasons but typically is due to a counterfeit MDI device.

To unblock the account, reach out to TCSC via CX Connect with the following information:

TCSC will be able to reach out to the Cybersecurity team that will be able to determine the cause of the block and may be able to unblock the account. In the case of a counterfeit MDI, the counterfeit tool must be destroyed, and a legitimate Bosch device must be used to ensure the ID is not blocked again. Repeat offenders may not be unblocked from access.

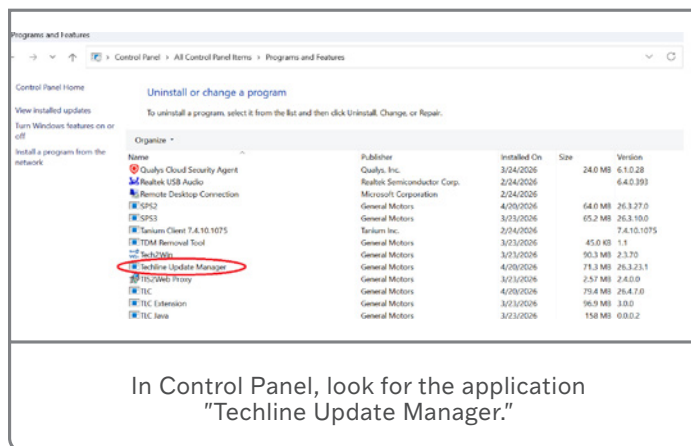
For the recent Techline Connect application update, your dealership's IT should whitelist the following files, in addition to the full list in the DISG, in order for Techline Connect to successfully update:

In Control Panel, if the application "Techline Update Manager" is not listed, reach out to your IT to have them whitelist all files before you restart Techline Connect as an administrator. If the issue remains, contact the Techline Customer Support Center (TCSC) for the file to be manually installed.

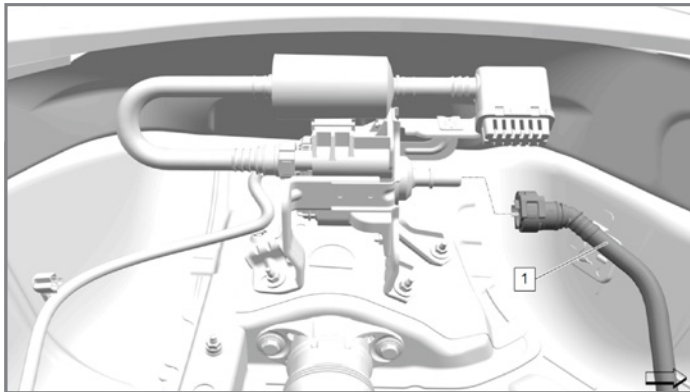
G34 EVAP Leak Detection Pump Assembly

Before performing EVAP system leak diagnostics based on DTC P0442 (Evaporative Emission System Small Leak Detected) or P0455 (Evaporative Emission System Large Leak Detected), the G34 EVAP Leak Detection Pump must be disconnected to prevent damage. Typical EVAP system testing is performed from the front of the vehicle to the back. For the 1.2L engine, the leak check pump is at the end of the line at the rear of the vehicle. If not

disconnected, smoke oil could collect in the pump, leading to pump failure. Do not allow smoke to enter the pump.
