## 2027 Bolt State of Charge and NACS Charging Tips

# 2027 Bolt State of Charge and NACS Charging Tips

# Inoperative PTO on Silverado Medium-Duty Trucks

# Rear Leaf Spring Noise and Possible Fuel Contamination

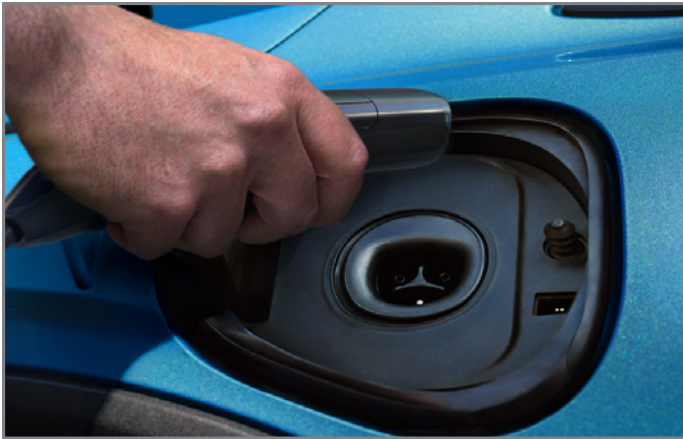
Bolt has a native NACS charging port.

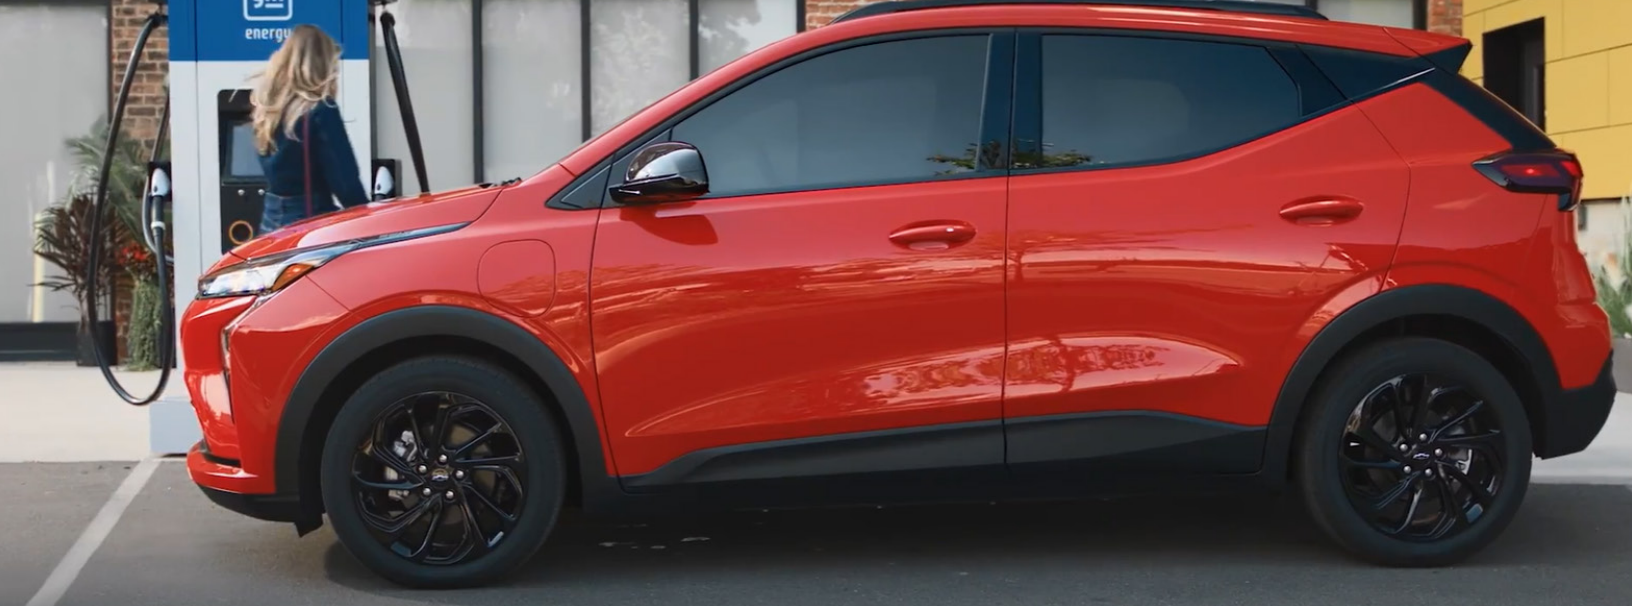
These conditions may be due to state of charge error growth after several cycles of usage without obtaining a complete charge at 100% SOC. Due to the flat voltage curve of the LFP battery, the Battery Management System needs to regularly obtain 100% SOC and Charge Complete status in order to learn and accurately maintain SOC. Charging the high-voltage battery to 100% SOC and Charge Complete status will correct these symptoms.

**TIP:** Do not stop charging until the Charge Complete message is shown. The instrument cluster display may indicate 100% SOC for several minutes while the SOC error is corrected.

Refer to Bulletin #26-NA-139 for more information.
