Gemini OTA Update for Google built-in

TCSC Top Issues This Week

Unable to Learn Trailer TPM Sensors

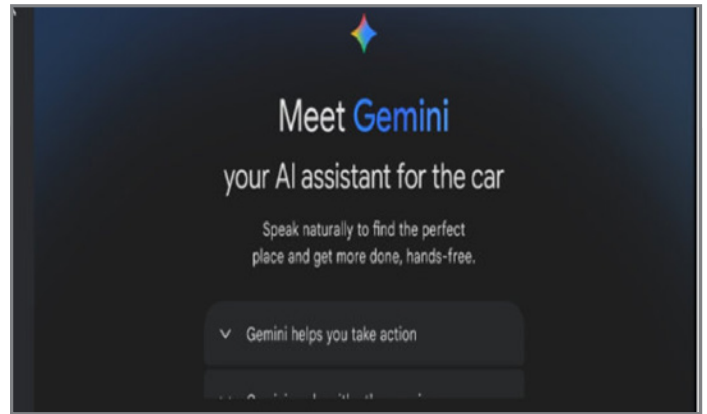
The Google Maps version must be 26.02.160000.E or higher.

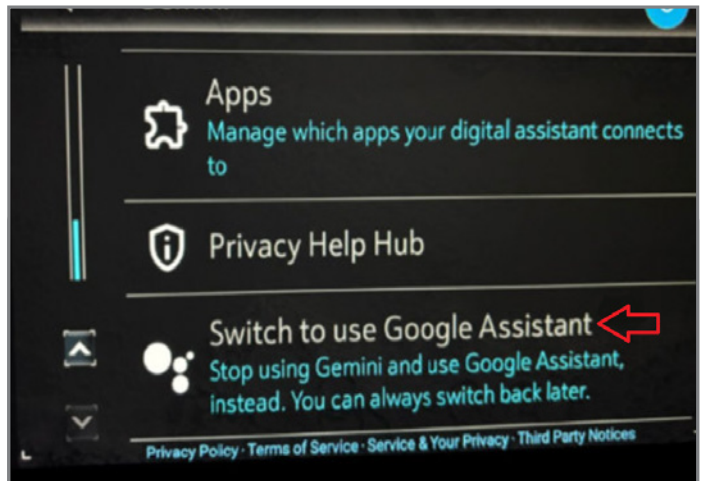
The Google Assistant app version for the Gemini opt-in must be 13.1.618.RC09 or higher. The example shown requires an update.

The Google Assistant app version for the Gemini opt-in must be 13.1.618.RC09 or higher. Update the app if needed.
