# Unable to Learn Tire Pressure Monitor Sensors

# Fuel Pump Power Control Module Internal Short

# Fuel Injection Pump Installation and Diesel Engine Timing

## TECH LINK

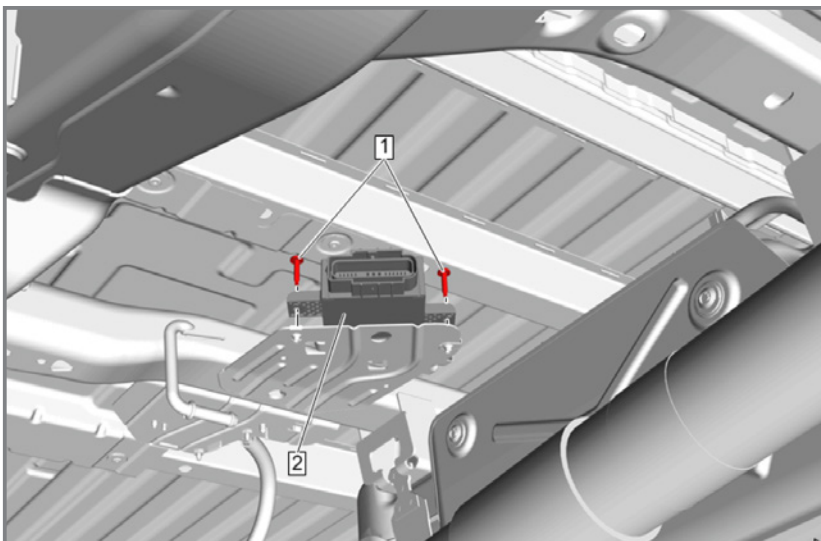
Some 2021-2022 Encore; 2021-2023 Tahoe, Suburban, Yukon, Envision, Escalade; 2021-2024 Blazer, Equinox, Express, Malibu, Trax, Acadia, Savana, Terrain, XT4, XT5, XT6; 2022-2023 Traverse, Enclave; 2022-2024 Silverado 1500, Sierra 1500; 2023-2024 Colorado, Canyon, Encore GX; 2024 Trailblazer, Silverado 2500HD/3500HD, Sierra 2500HD/3500HD models and 2021-2023 Camaro models equipped with the 2.0L engine (RPO LTG) may have a crank/no start condition and an illuminated Check Engine MIL. DTC P023F (Fuel Pump Control Circuit) and/or P129F (Fuel Pump Power Control Module Fuel Pump Speed Signal Incorrect) will be set in the Engine Control Module (ECM).

DTCs P102A (Fuel Pump Motor Phase U-V-W Circuits Low), P102B (Fuel Pump Motor Phase U-V-W Circuits High), P1029 (Fuel Pump Motor Phase U-V-W Circuits), U18A2 (Lost Communication with Fuel Pump Driver Control Module) and P0627 (Fuel Pump Enable Circuit) also may be set.

These conditions may be caused by an internal short in the K111 Fuel Pump Driver Control Module (FPDCM)/Fuel Pump Power Control Module.

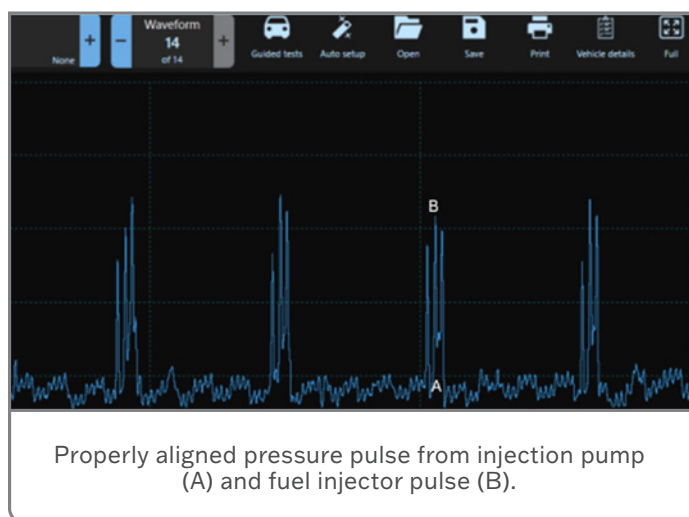
The 3.0L diesel engine uses a two-cylinder fuel injection pump. Each cylinder has a fuel regulator that sends fuel into a shared fuel rail. Because of the timing chain gearing between the crankshaft and the fuel injection pump, one pump piston reaches top dead center during each of the engine cylinder's power strokes.

For the engine to run correctly, the fuel pulse from the injection pump must line up the moment the fuel injector opens for the cylinder that is firing. If this timing is off even slightly, the DTCs may set or the engine may not start.

When working on an engine that has low-pressure codes or won't start after replacing the fuel injection pump, check the timing with a PicoScope. To do this, connect the scope to the fuel rail pressure sensor. Look at the pressure pulse from the injection pump and the fuel injector pulse. On a properly timed engine, the injection pump pulse will be aligned with the fuel injector pulse.
