## Ethernet Cable Overlay for Telematic Control Module Interference

# Ethernet Cable Overlay for Telematic Control Module Interference

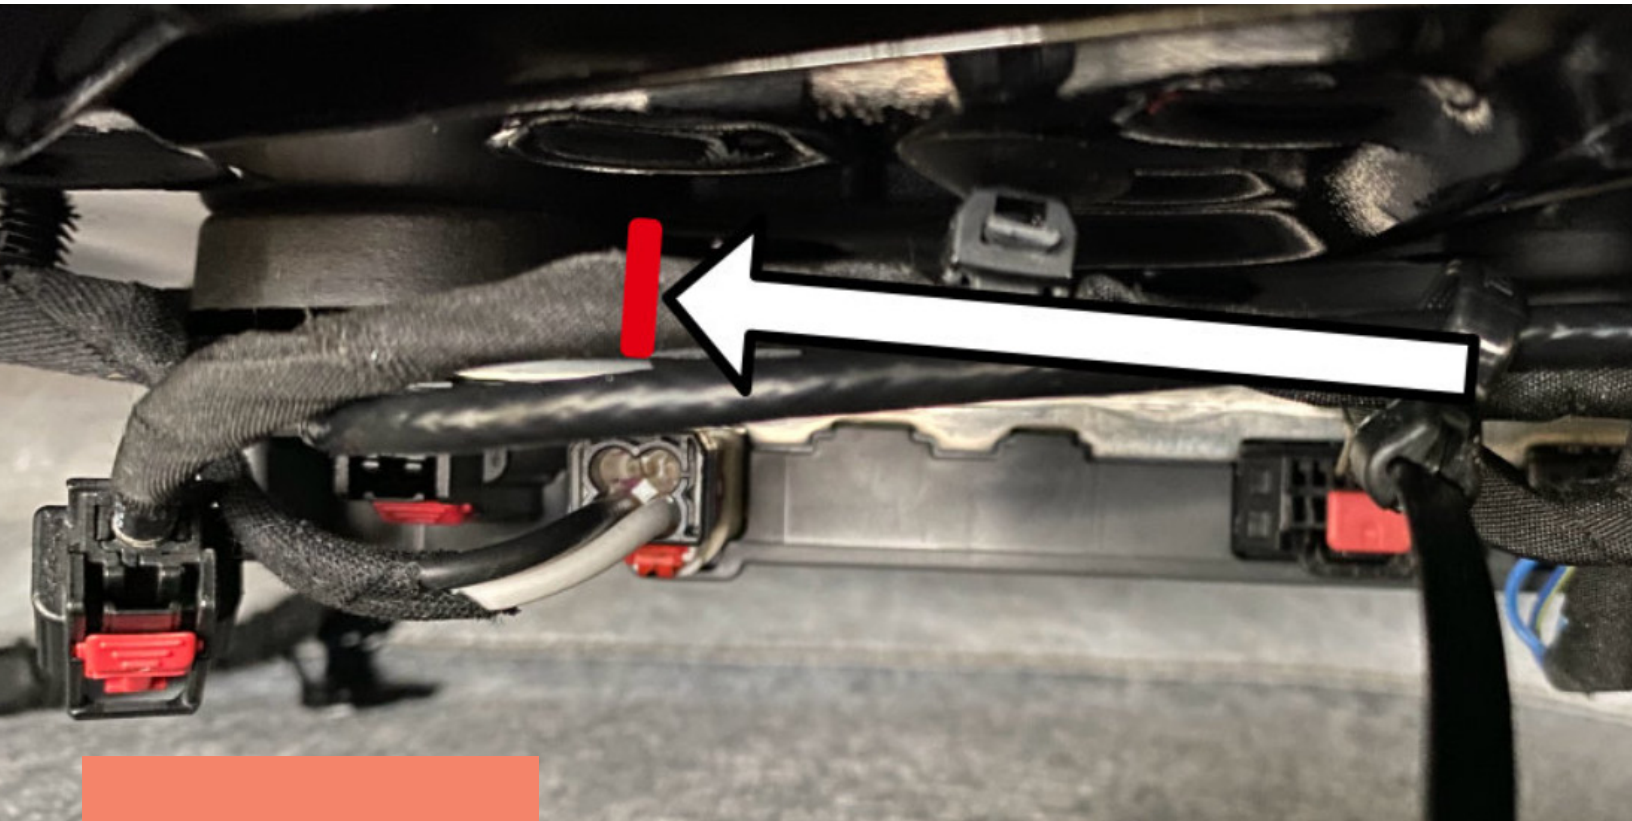
Interference from the Telematic Control Module may be due to an intermittent grounding issue from the X7 connector on the Ethernet cable.

These conditions may be caused by interference from the Telematic Control Module (OnStar module) due to an intermittent grounding issue from the X7 connector on the Ethernet cable. To correct these conditions, replace the Ethernet cable with a cable overlay.
