# GM TECHNICAL ASSISTANCE CENTER (TAC)

## Dealer Tips and New Information Newsletter

SEPTEMBER 24, 2026

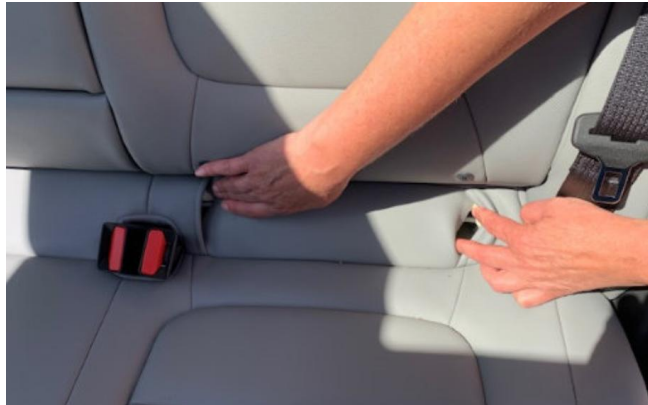
It provides information for locating the lower rear child seat latch anchors. Each anchor position has a label near the crease on the seatback. The anchor is located in the crease.
