GM TECHNICAL ASSISTANCE CENTER (TAC)

Dealer Tips and New Information Newsletter

March 1, 2022

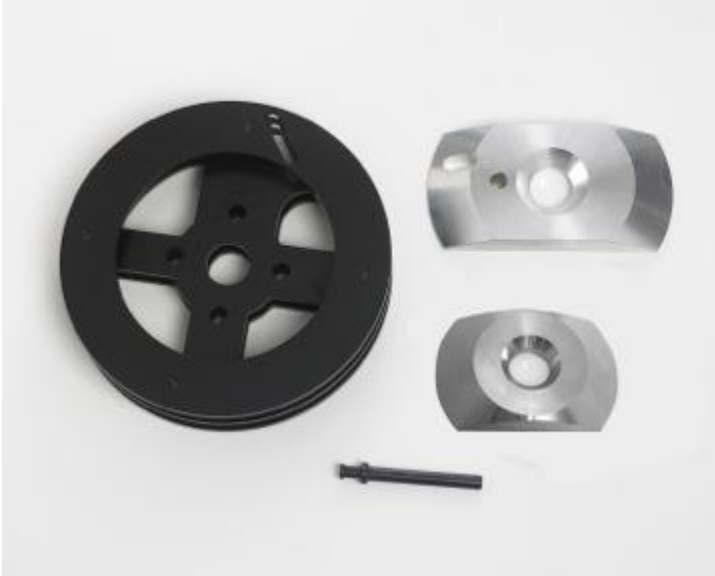
20-2964-1 Kit-Large Bore, Dual Wheel – Expands clamping capability into 16-inch, 17-inch, 19.5-inch and more dual-wheel applications. Suitable for Revolution Tire Changer only.

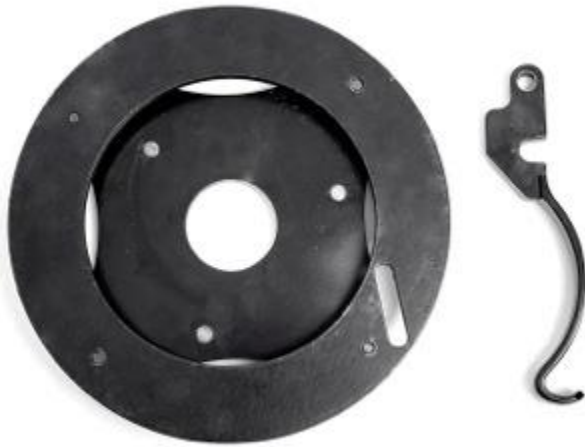
20-3160-1 Thick Bead Kit for Revolution – Includes thick bead hook and reverse wheel adaptor. Suitable for load range G, H, J tires. Suitable for all generations of Revolution Tire Changers running 1.4 or greater software.
