GM TECHNICAL ASSISTANCE CENTER (TAC)

March Newsletter

March 01, 2022

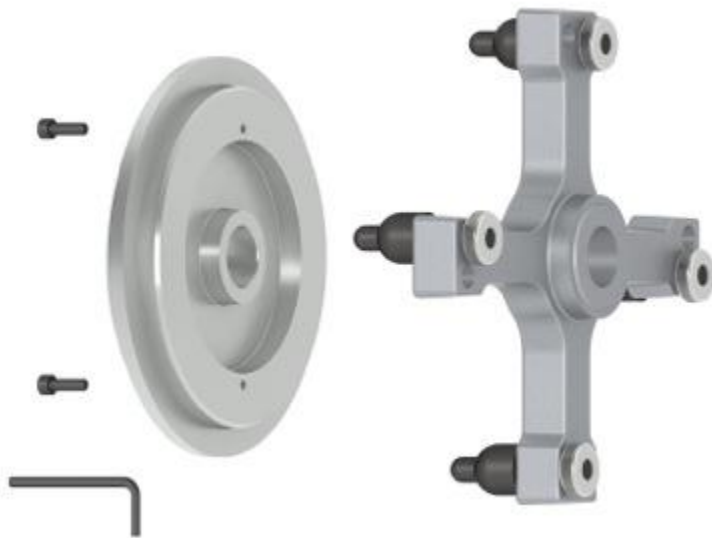
Balancer

20-2977-2 Large Bore 8 Stud Kit – 8.7-inch bore for use with medium-duty trucks with 19.5-inch rims.
