GM TECHNICAL ASSISTANCE CENTER (TAC)

Dealer Tips and New Information Newsletter

MARCH 25, 2026

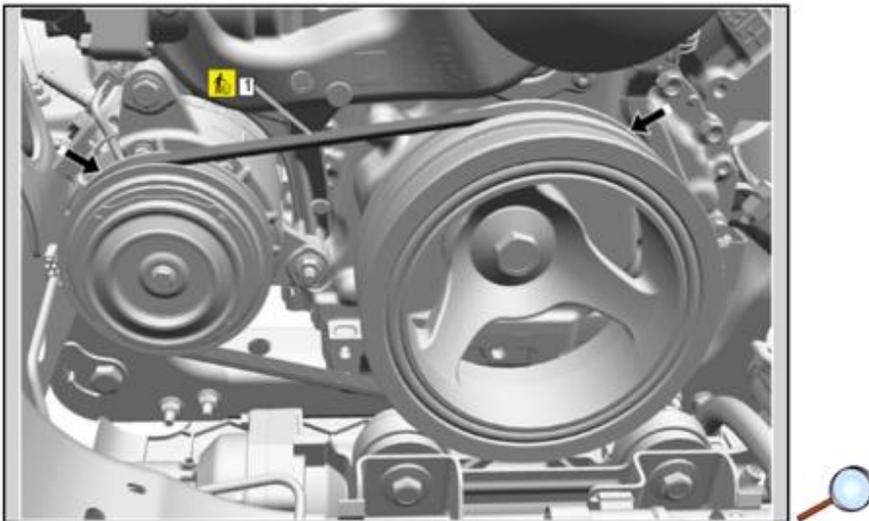
Note: The OEM replacement accessory drive auxiliary belt (1) is packaged with a disposable installation tool and installation instructions.

232. Install the accessory drive auxiliary belt (1) following the instructions included with the accessory drive auxiliary belt.

Upon review of the Engine Removal and Installation service procedure and to help prevent bearing damage, the Engine Prelubing step has been moved before the installation of the accessory drive belts. The reason this change was made is to ensure the lower crankshaft bearings and journals have an adequate amount of oil before rotating the engine dry during drive belt installation.
